**Complex Site Conditions**

**110+ Conflicts**

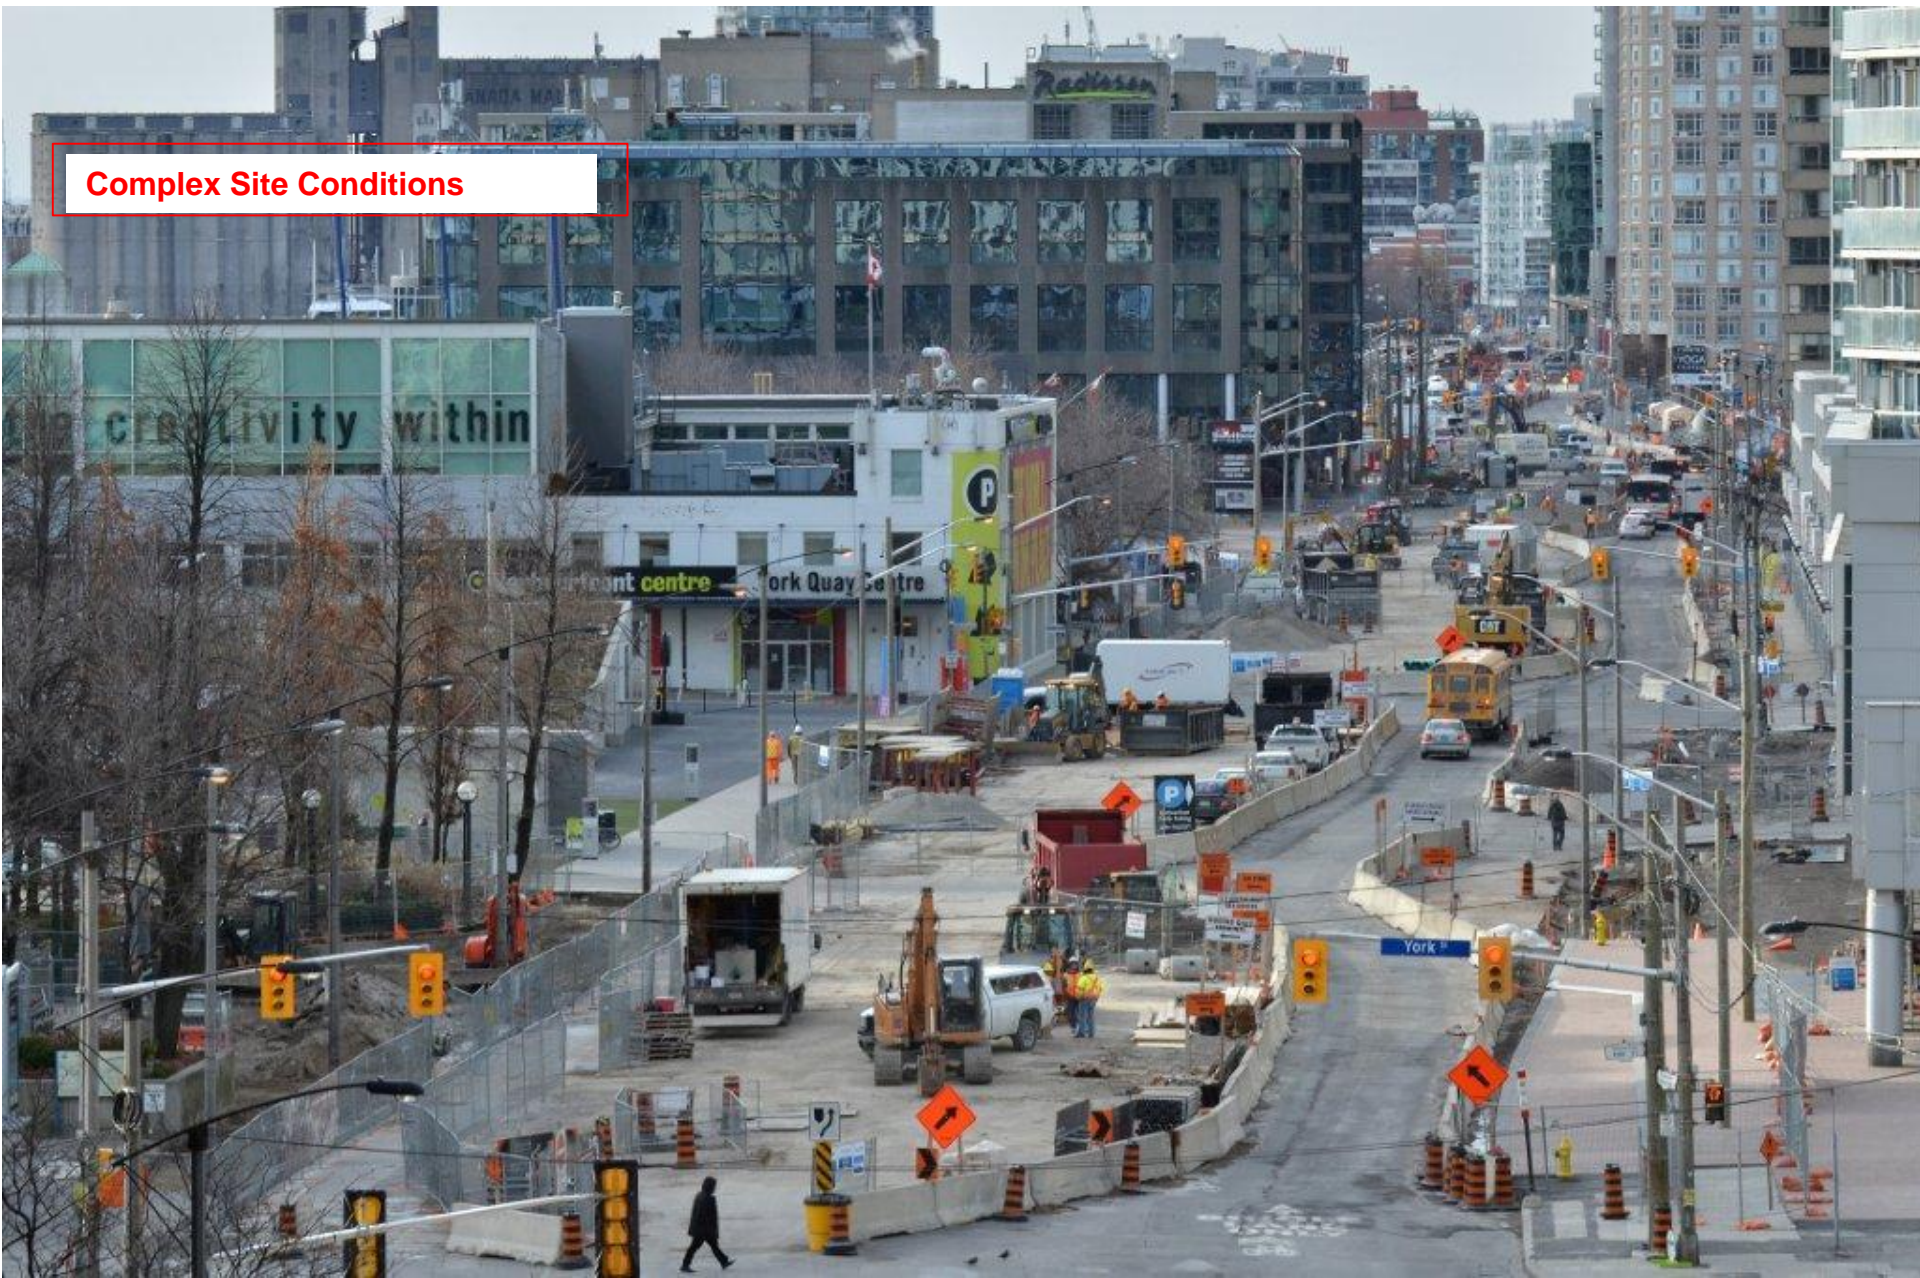
Aerial view showing several different contractors working across the site at the same time and the traffic management required to keep the street open to traffic

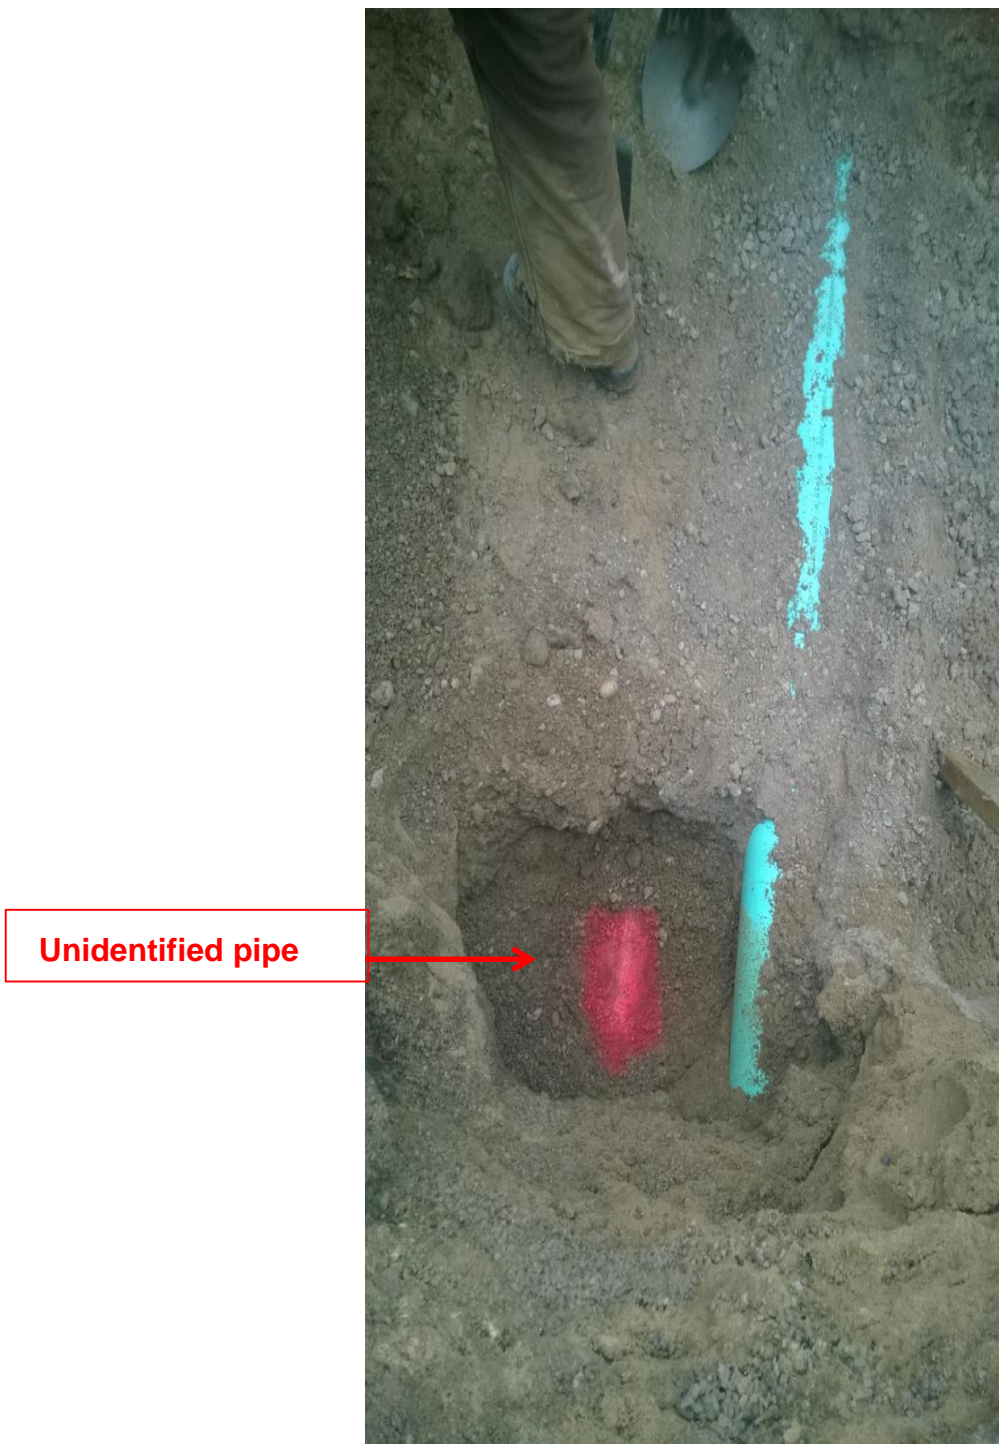
Another example of a piece of infrastructure not shown on City as-built drawings. Work had to stop until the unknown pipe could be identified as it was in direct conflict with the new storm line being installed.

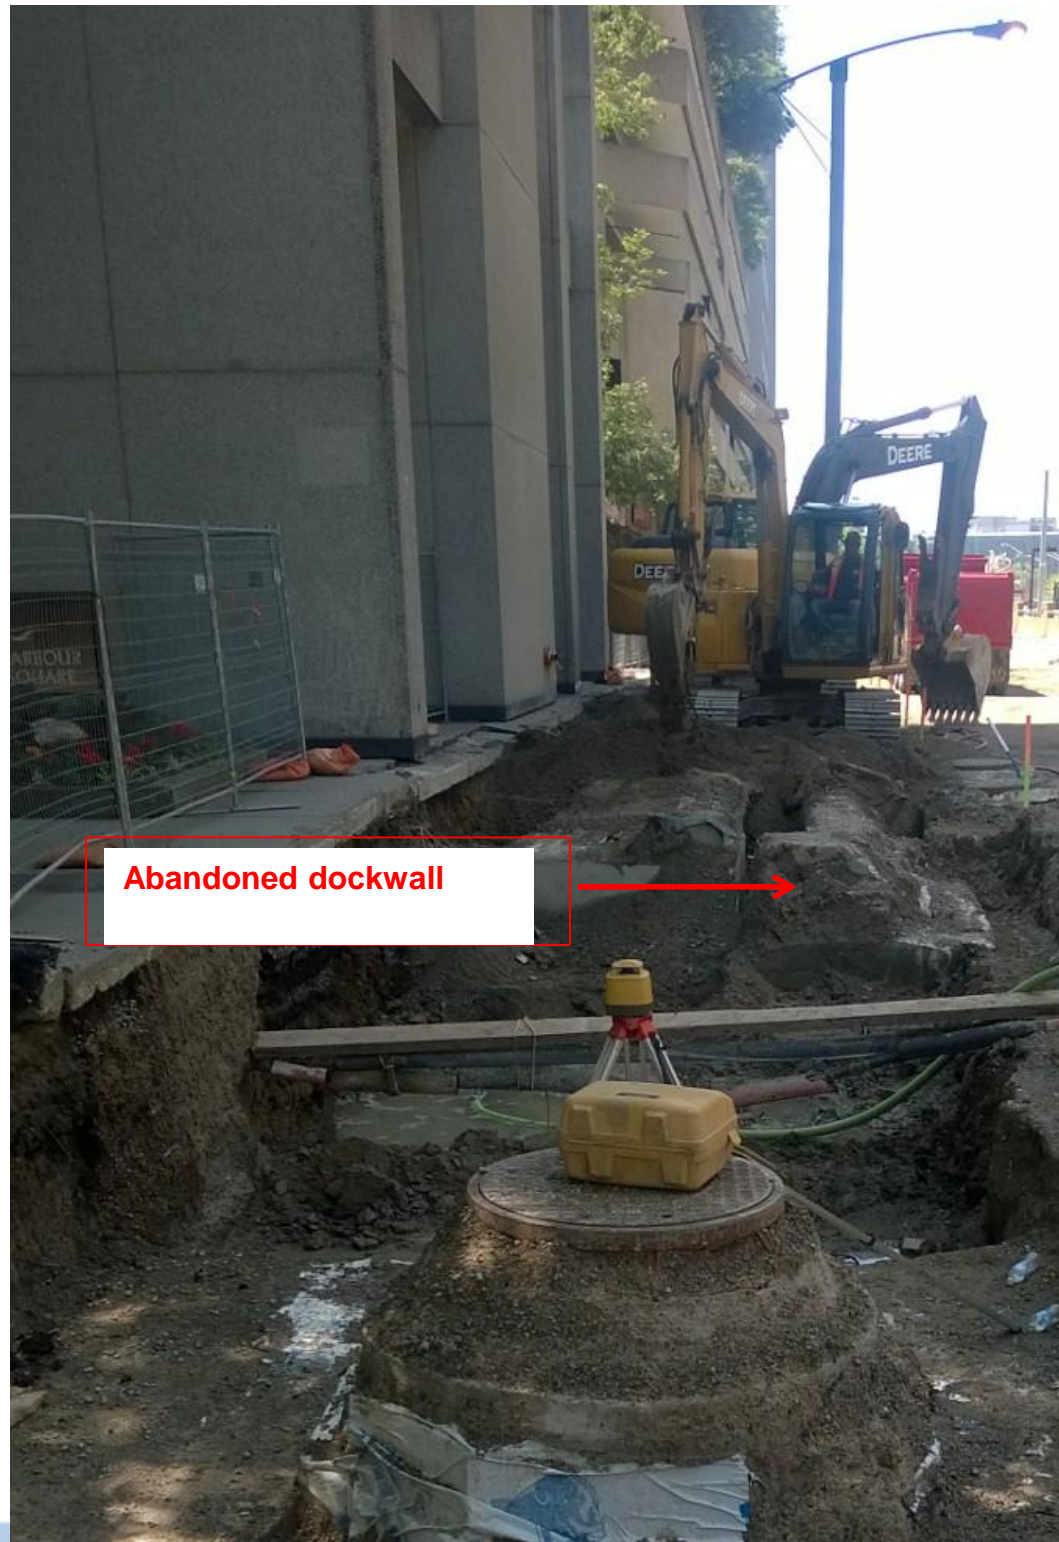
An abandoned dockwall was uncovered during construction. This old infrastructure was not shown on City as-built drawings and additional work and time was required to remove the dockwall so that work could proceed.

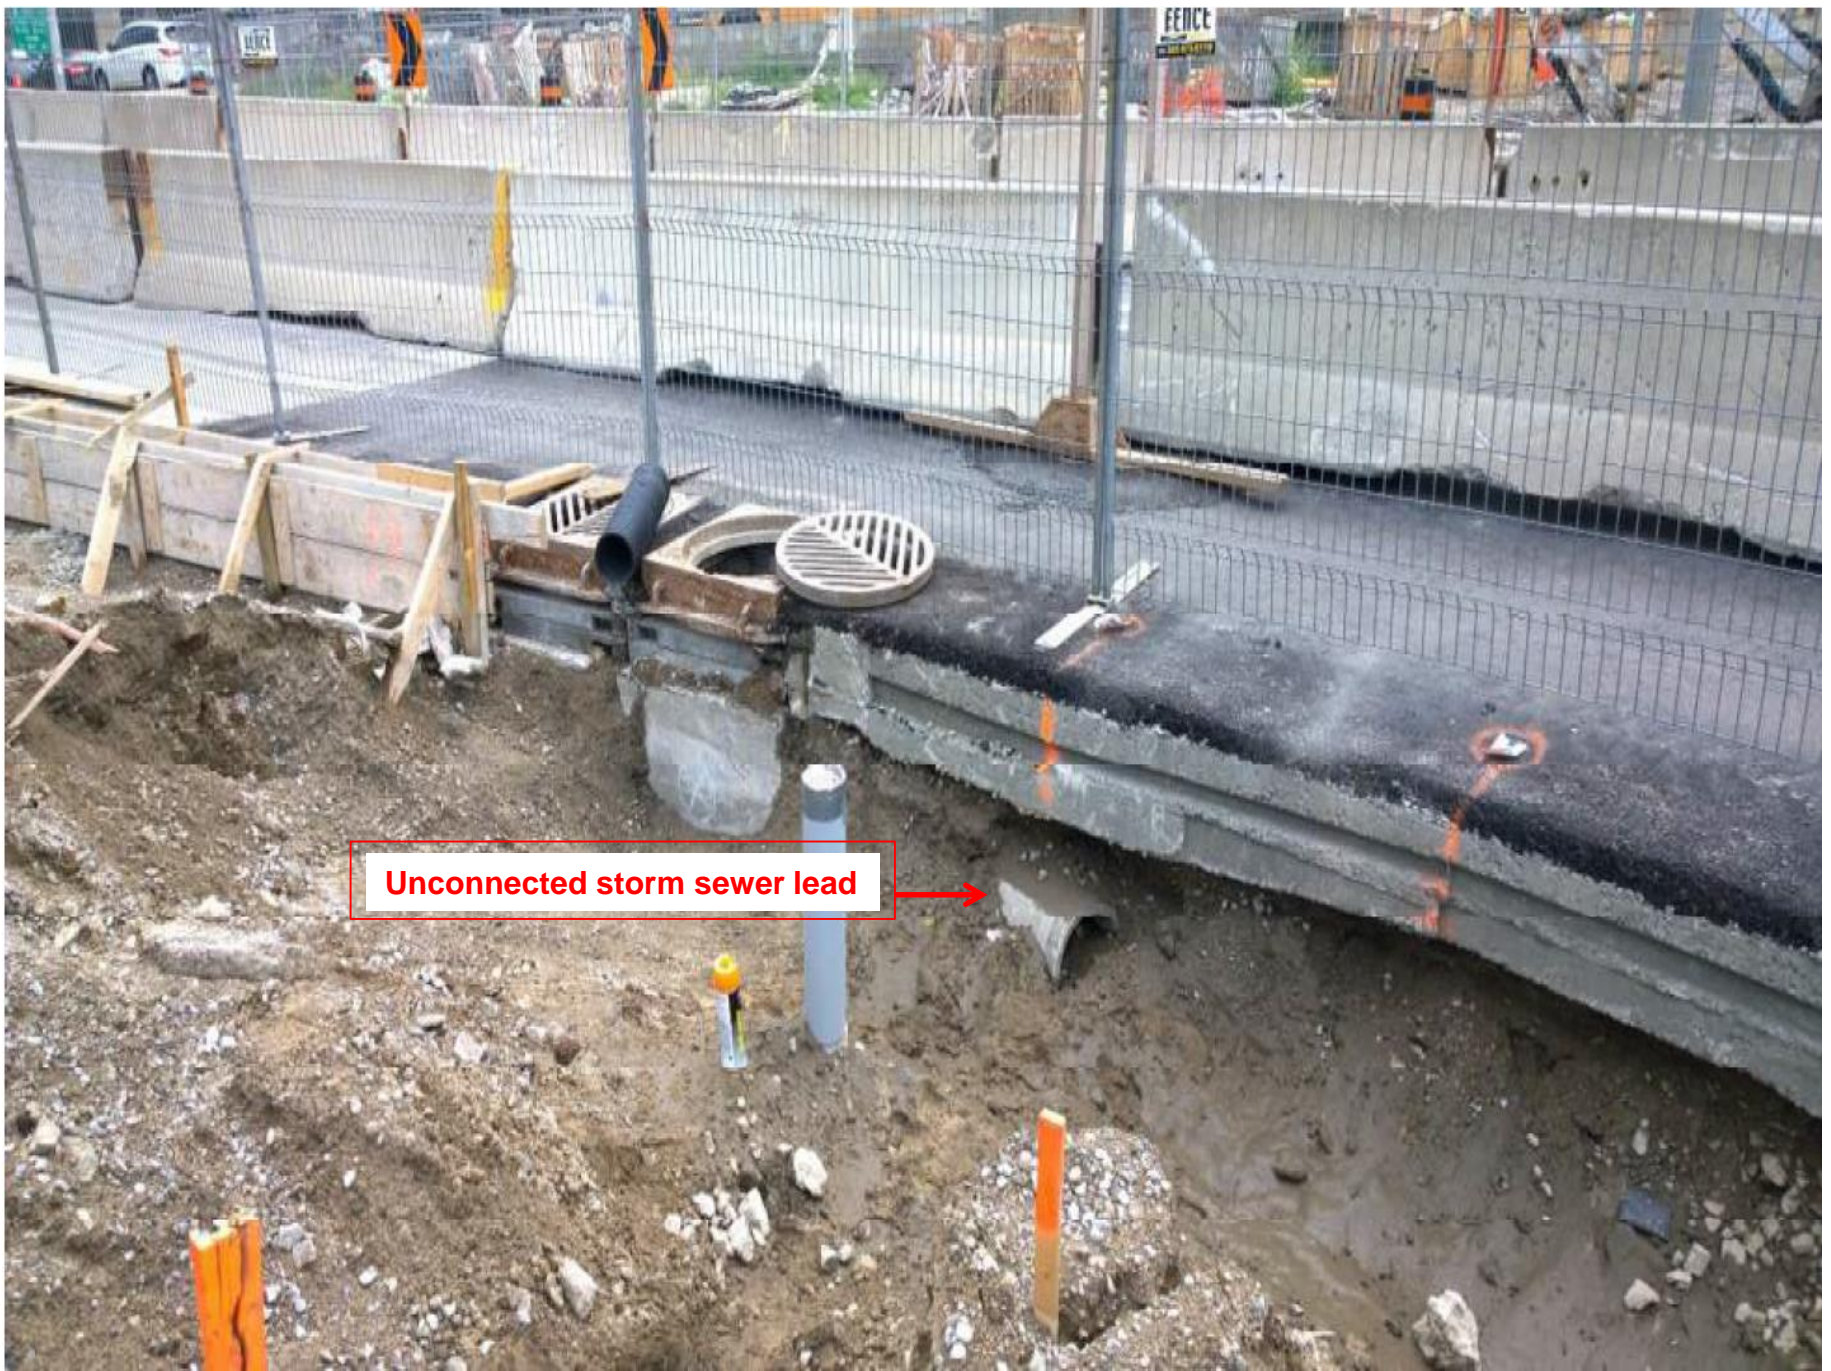
Upon excavation for new landscaping, crews discovered that an existing storm lead was not connected to the main storm sewer. This storm lead had to be redesigned and redirected north (not part of project scope).

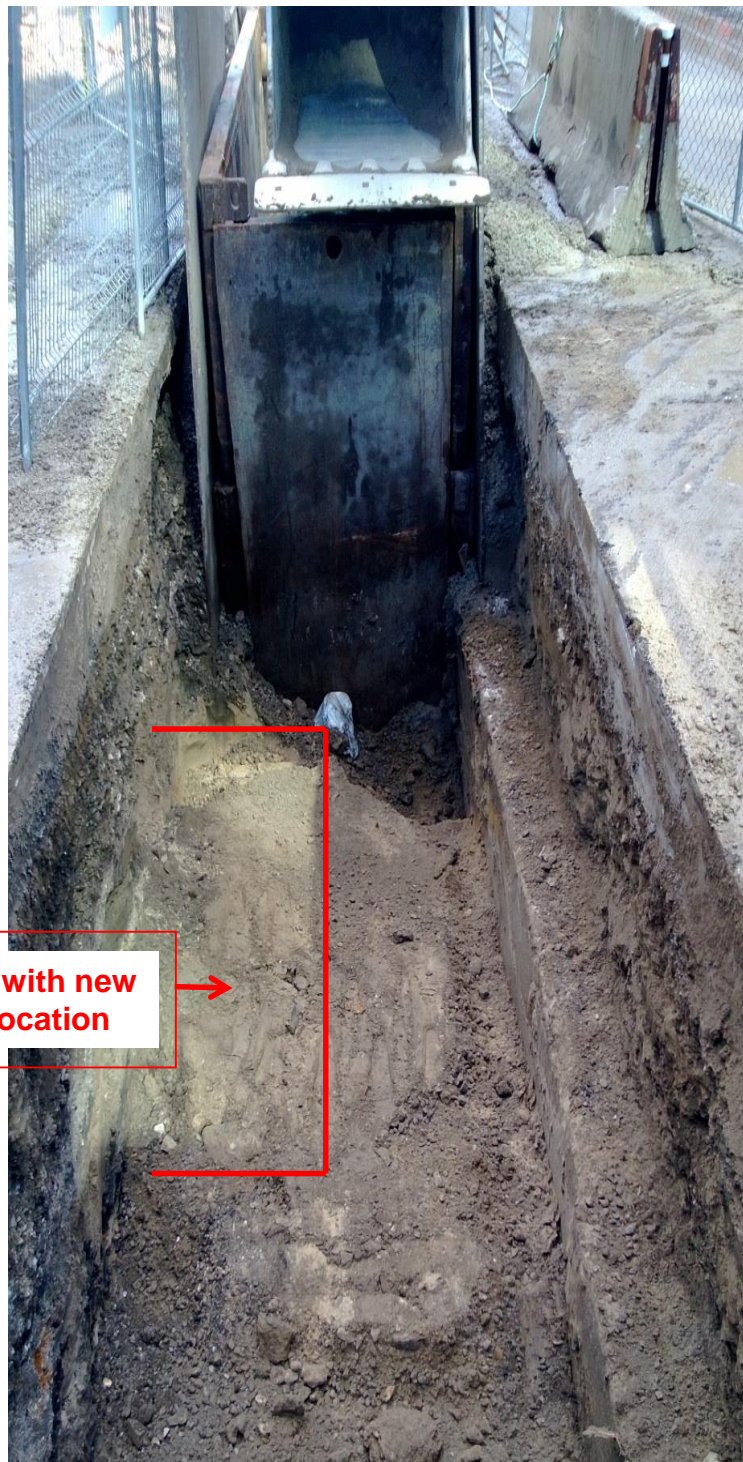
**Toronto Hydro ductbank in conflict with new sanitary sewer proposed for same location**

Toronto Hydro ductbank (not shown on as-built drawings) discovered when crews excavated for the new sanitary sewer proposed in the same location.

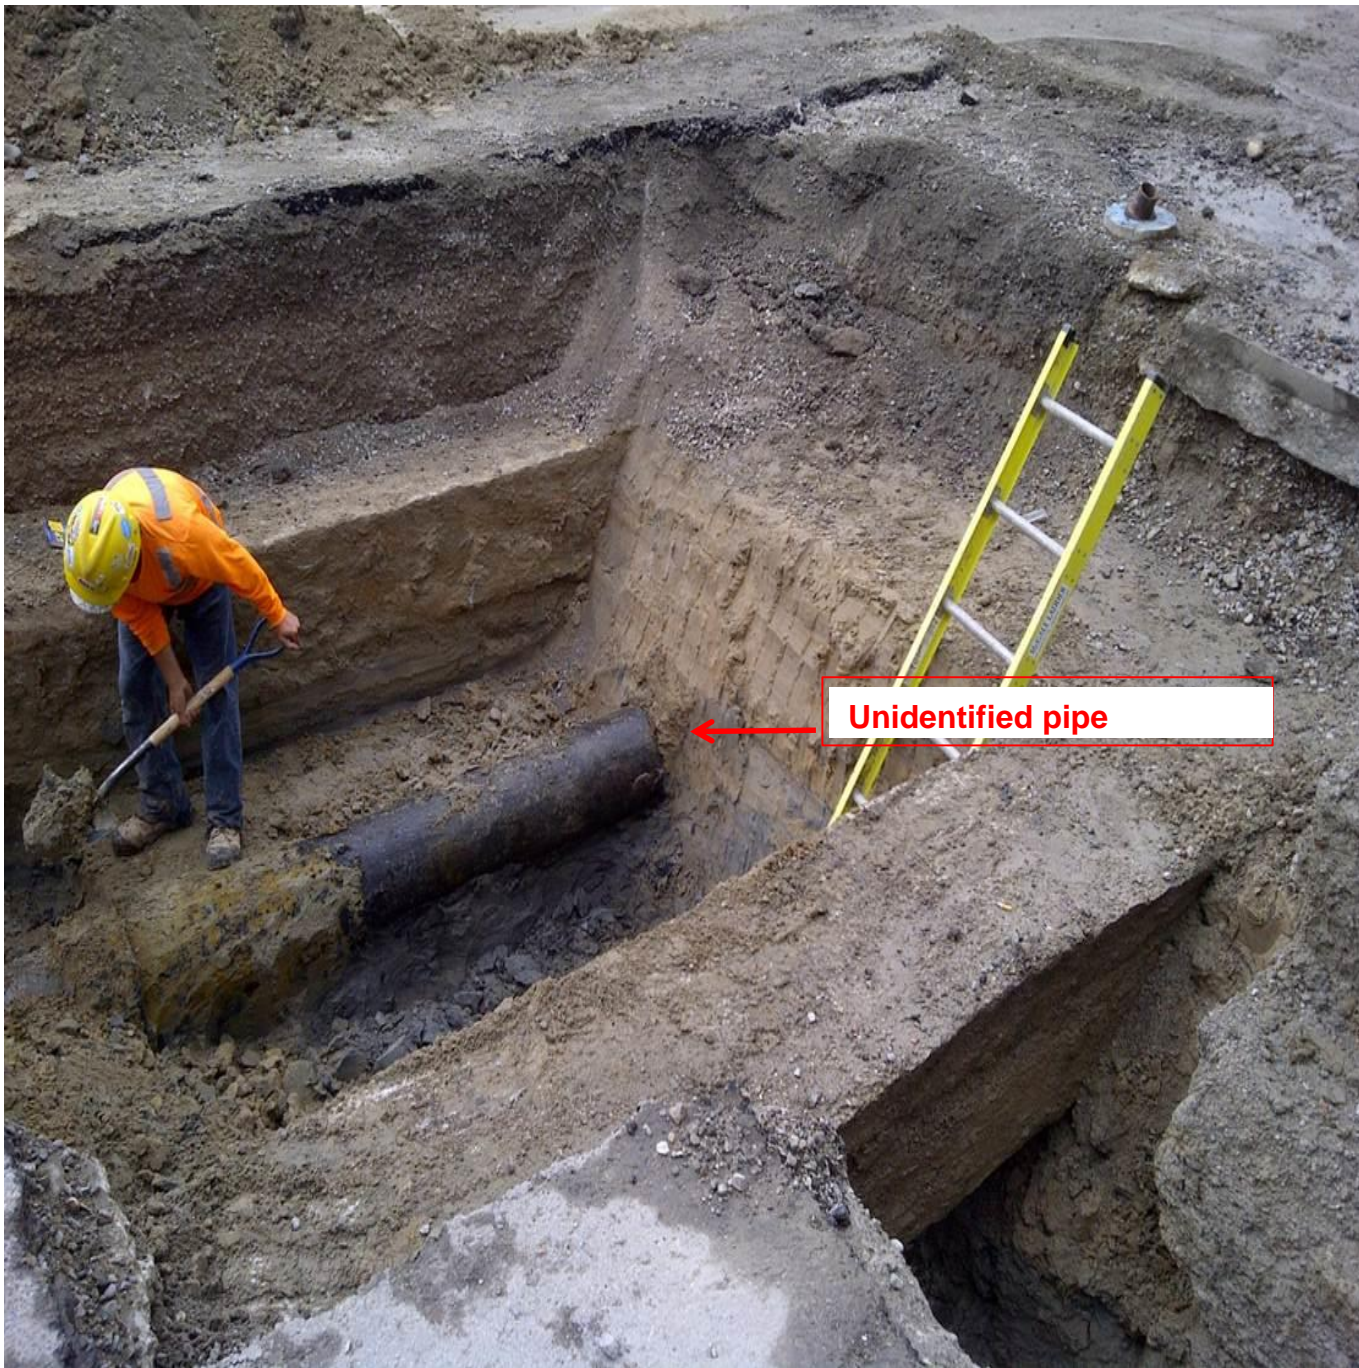
Excavating around unidentified pipe not shown on City “as-built” drawings.

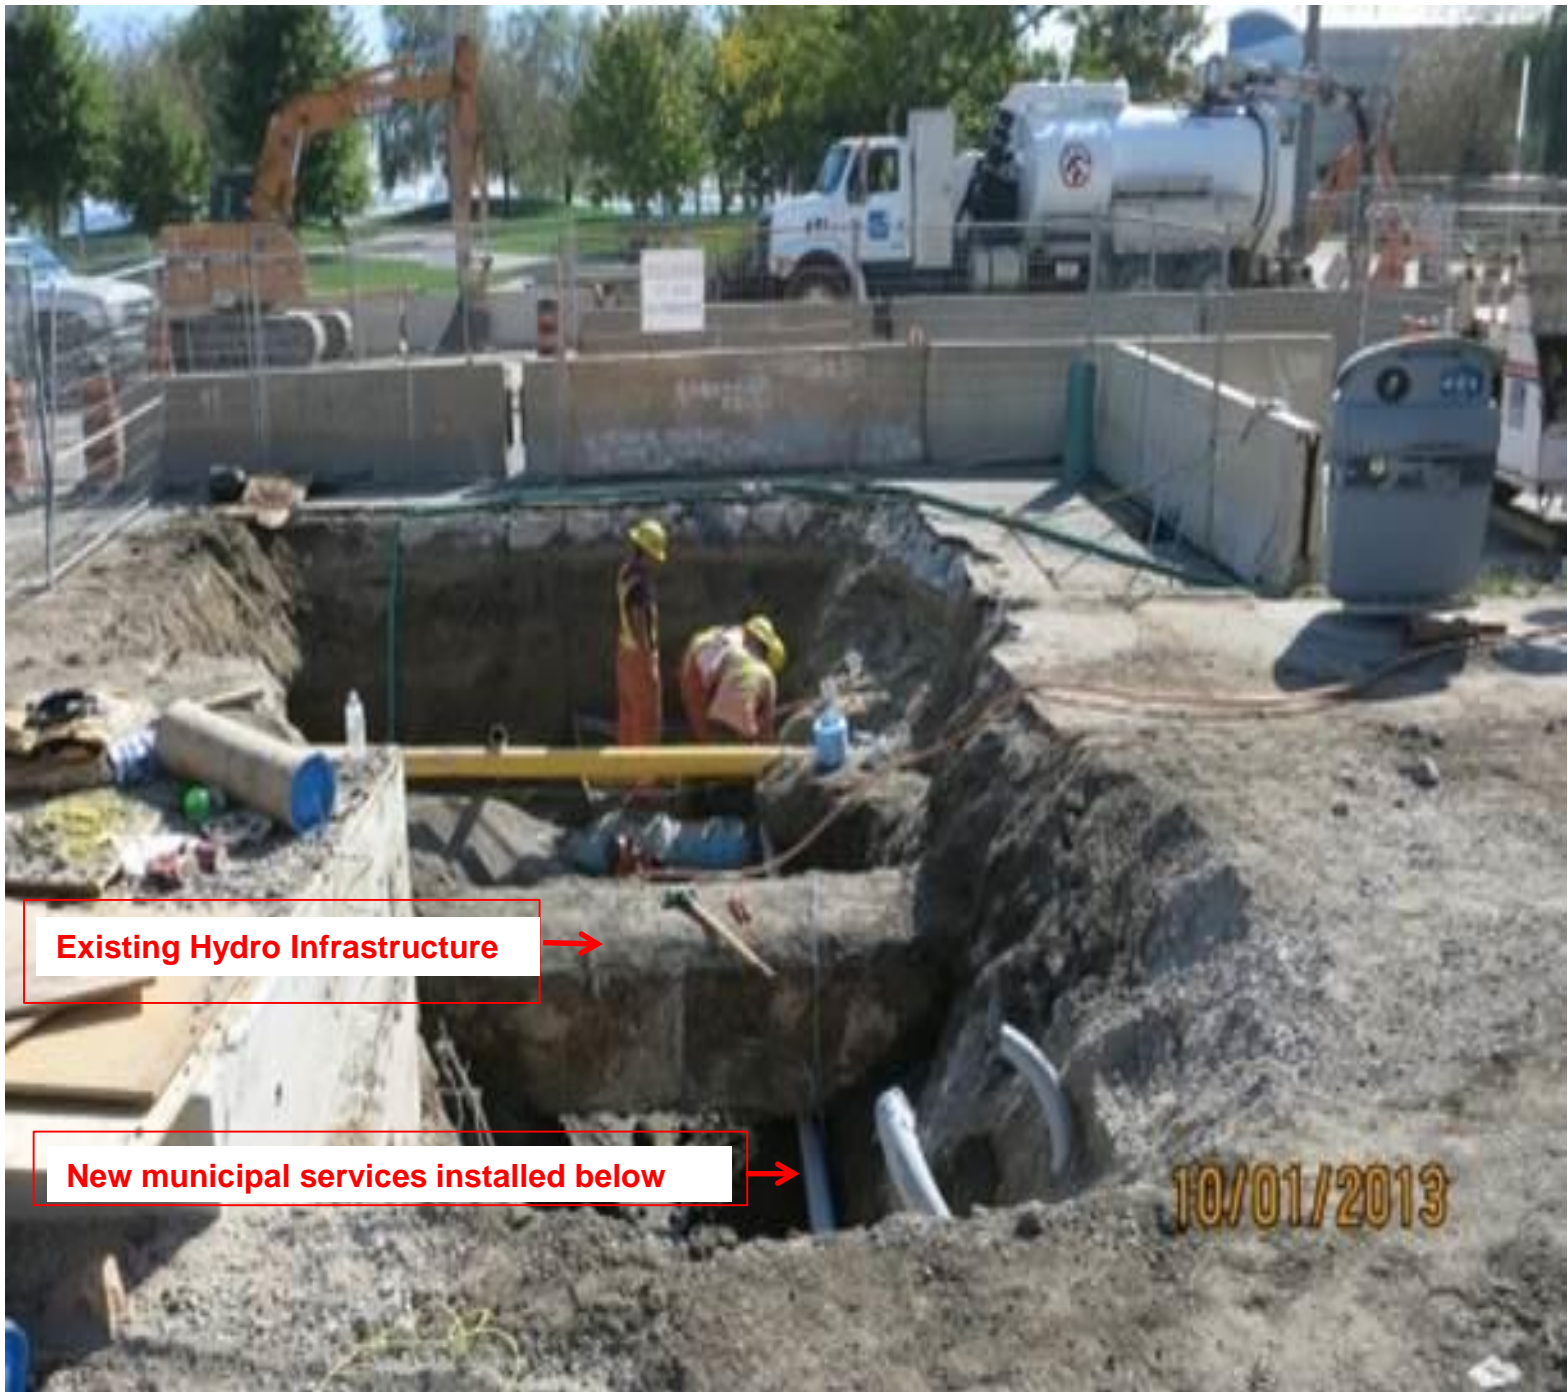
Crews work around a conflict with existing hydro infrastructure in order to install required municipal services in the same location.

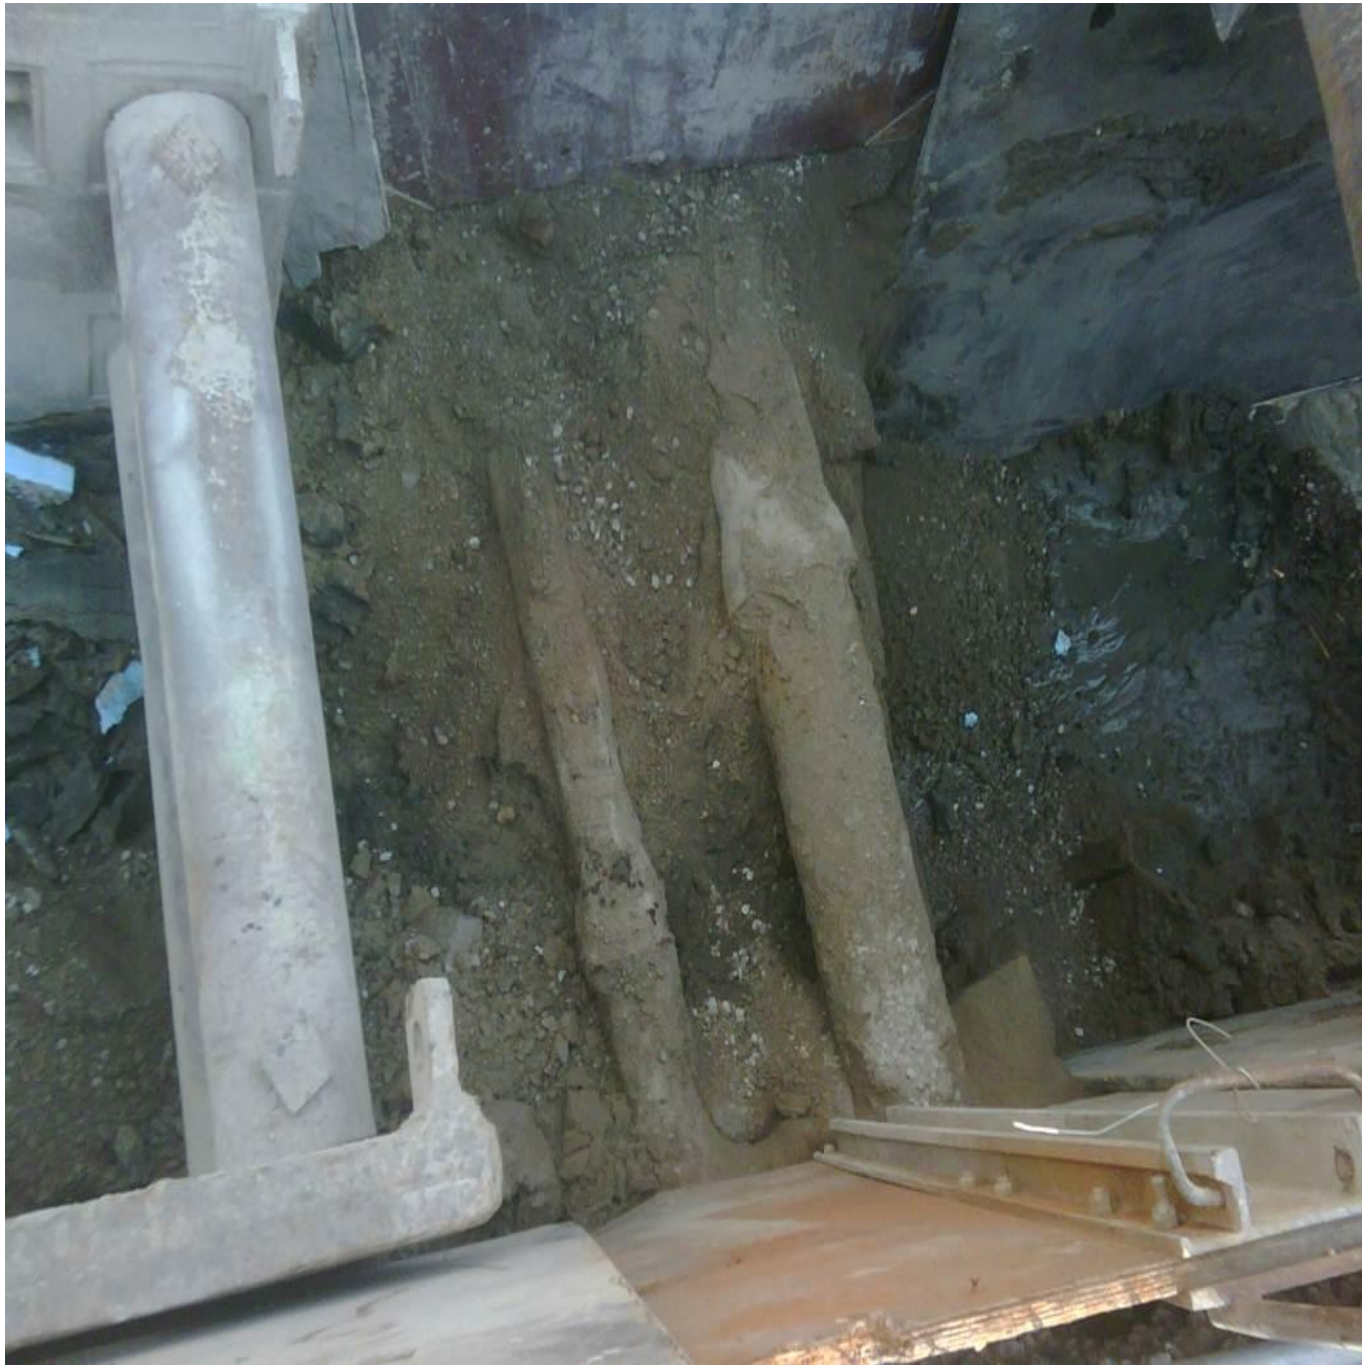
Unknown pipes not indicated on City surveys/as-built drawings. Work has to stop when these are uncovered and time is required to determine the owner/usage, and possible redesign.

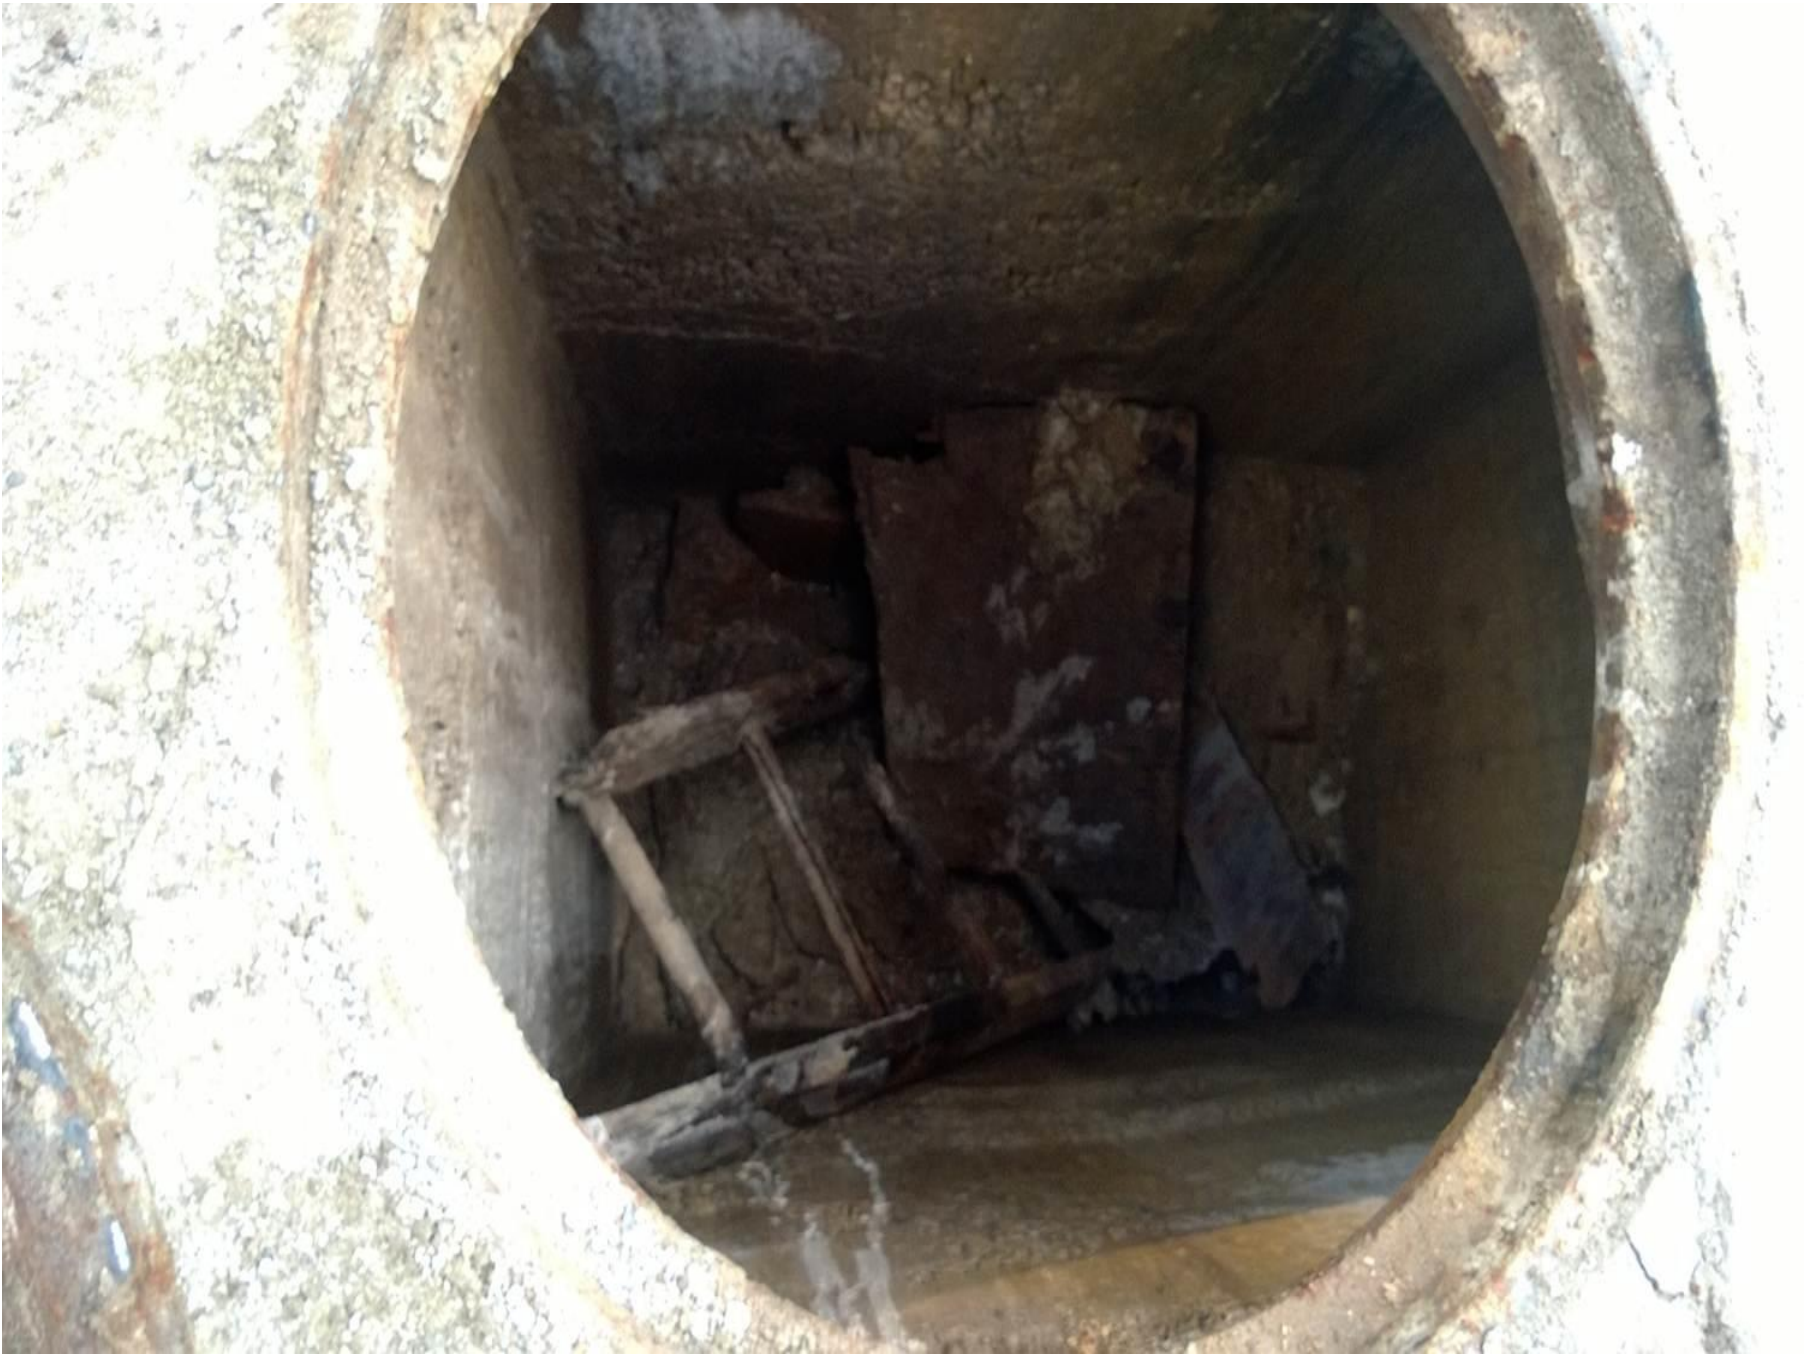
Abandoned manhole not on as-built drawings.

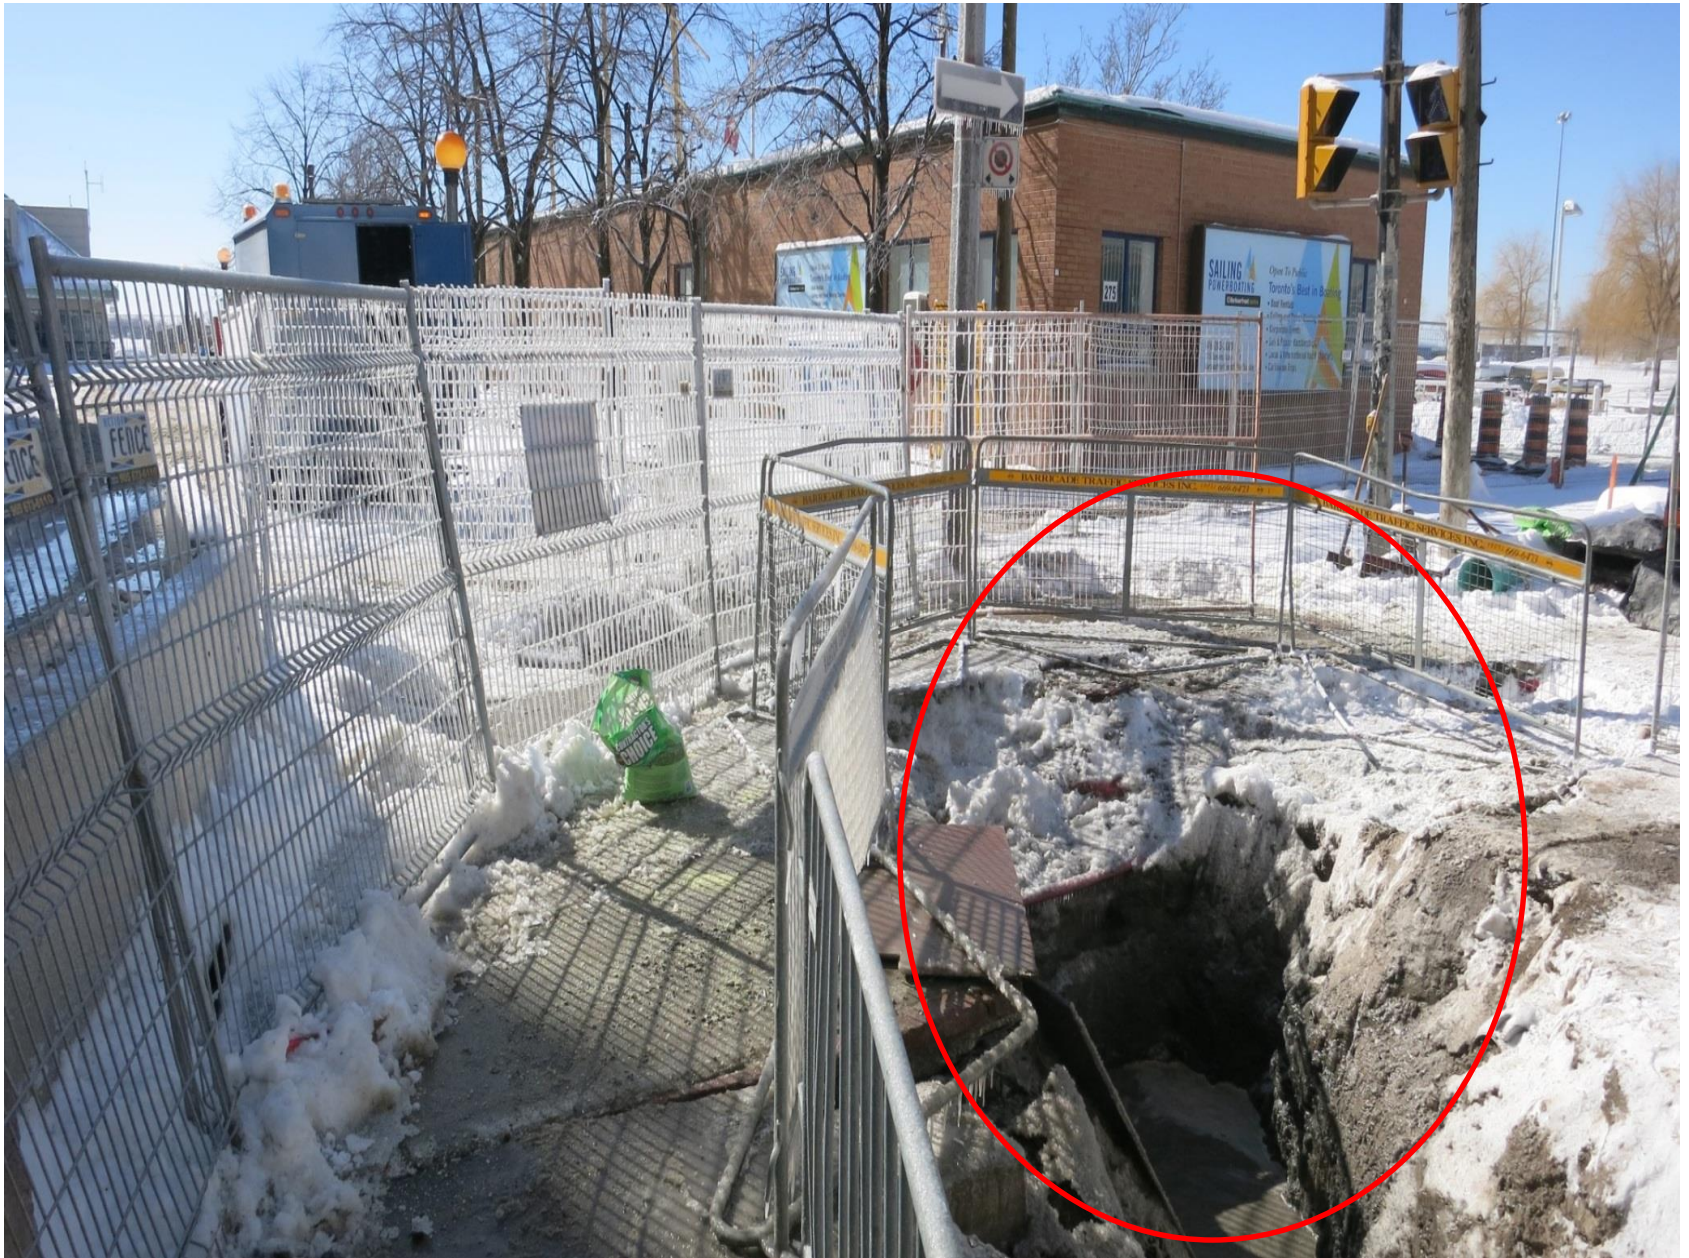
Several watermains (which were not scheduled to be replaced) failed while work was underway in adjacent areas and had to be rebuilt. Work was not part of project scope.

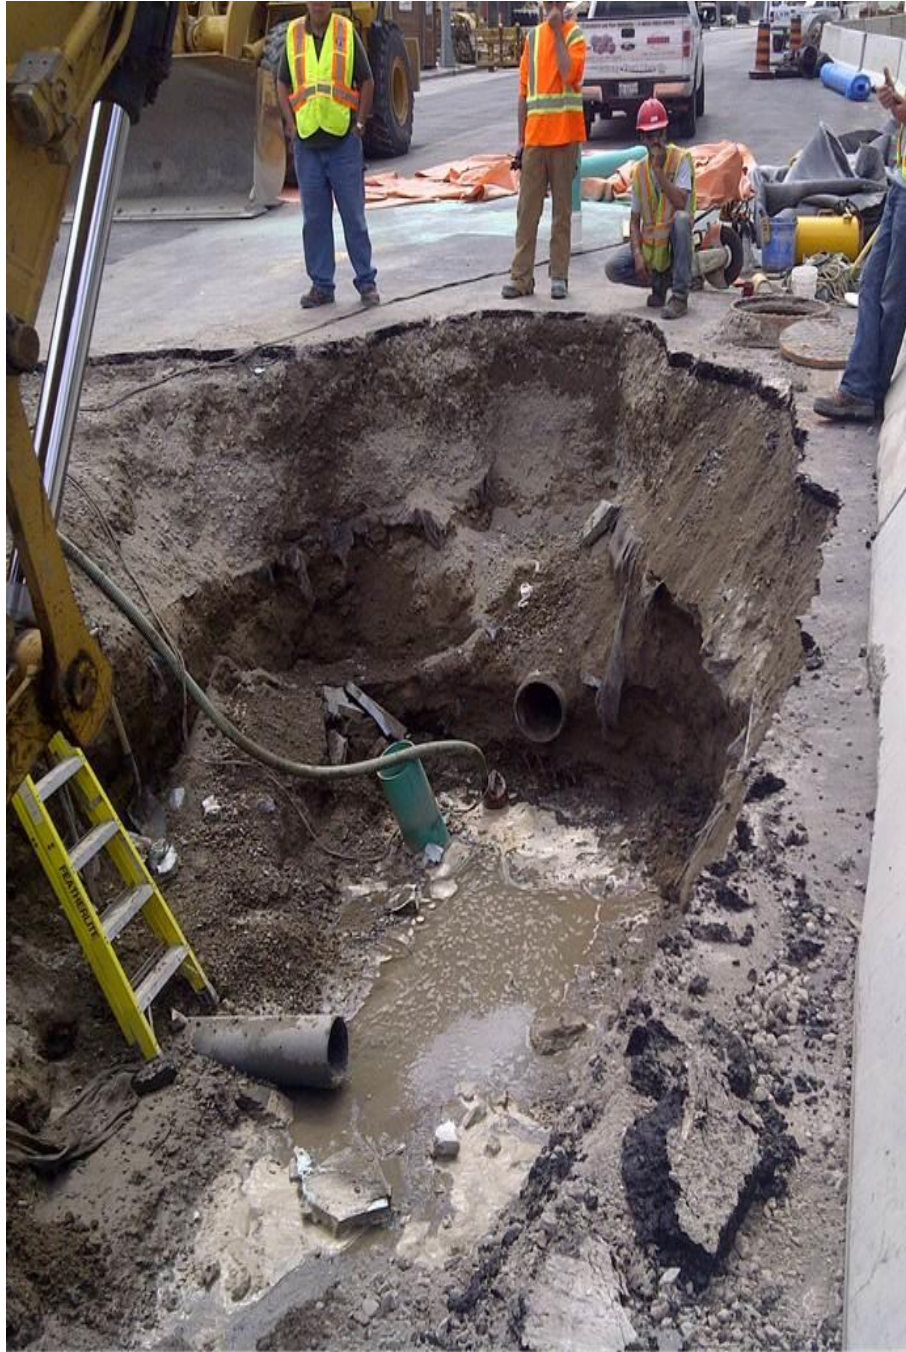
This watermain failure also resulted in a sinkhole due to the poor soil conditions. The watermain was rebuilt (not part of project scope) and sinkhole filled.
