**Complex Site Conditions**

**110+ Conflicts**

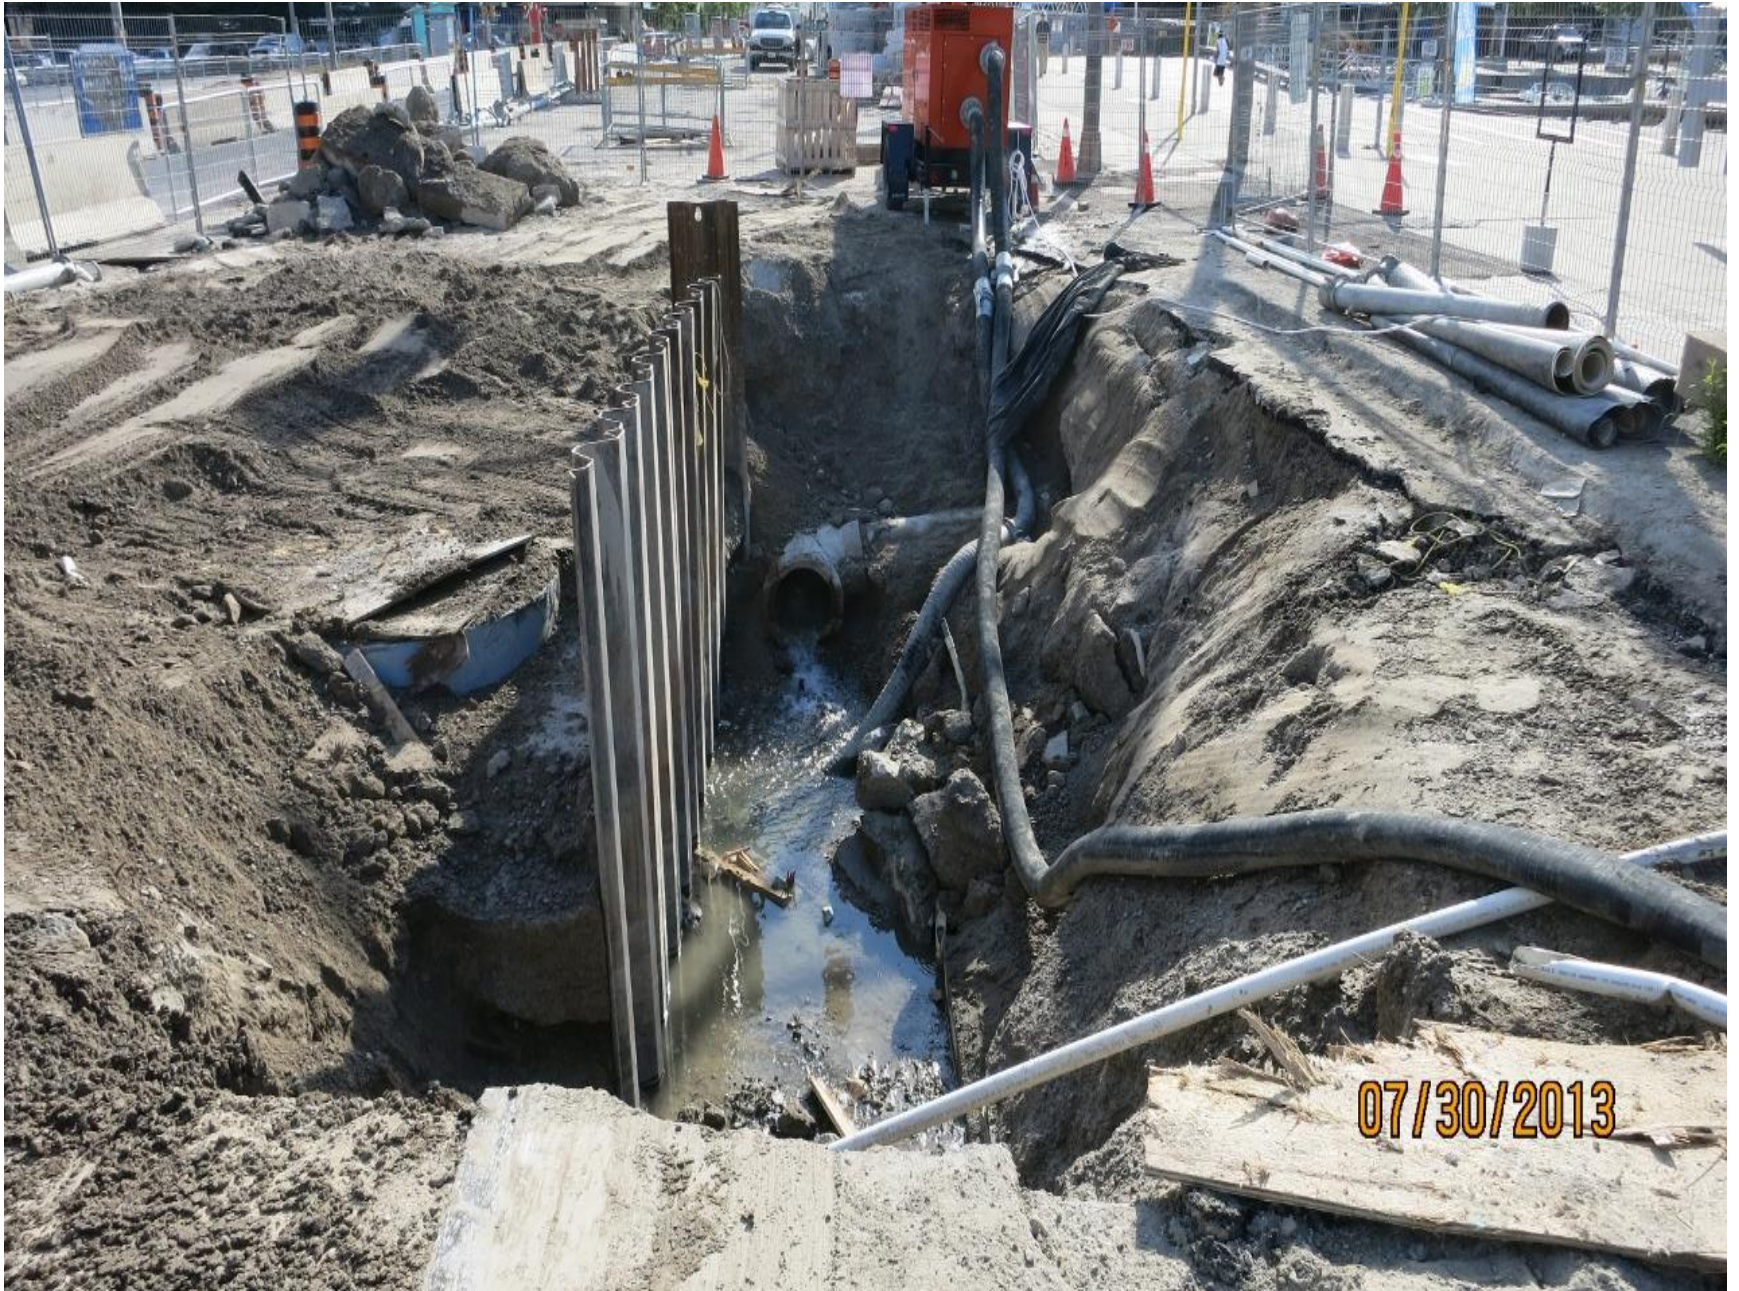
An existing storm pipe failed while work was underway in a nearby location and had to be repaired (not part of project scope).

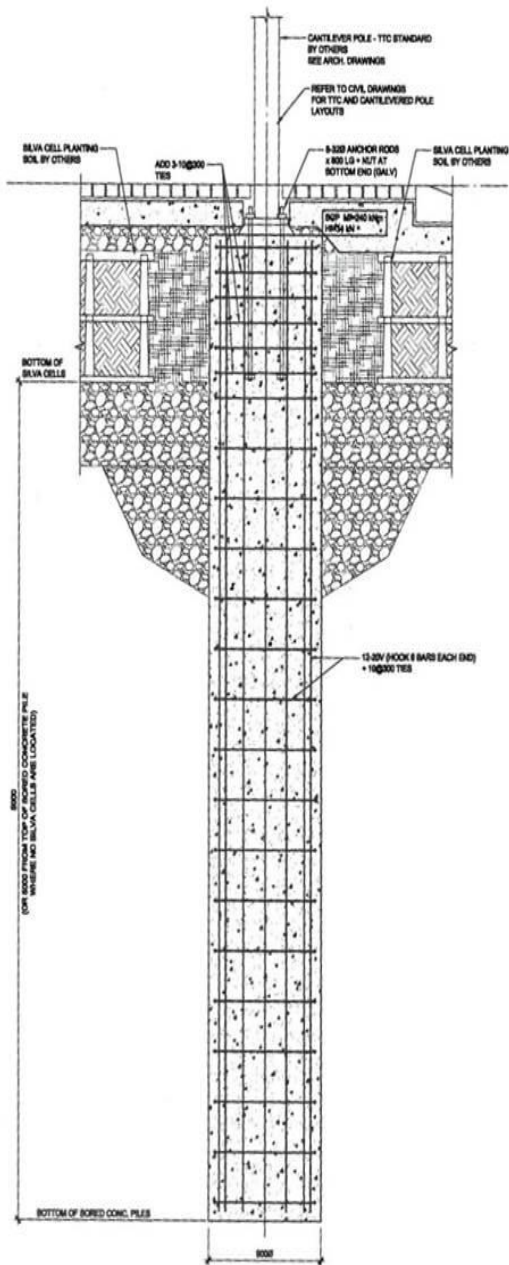
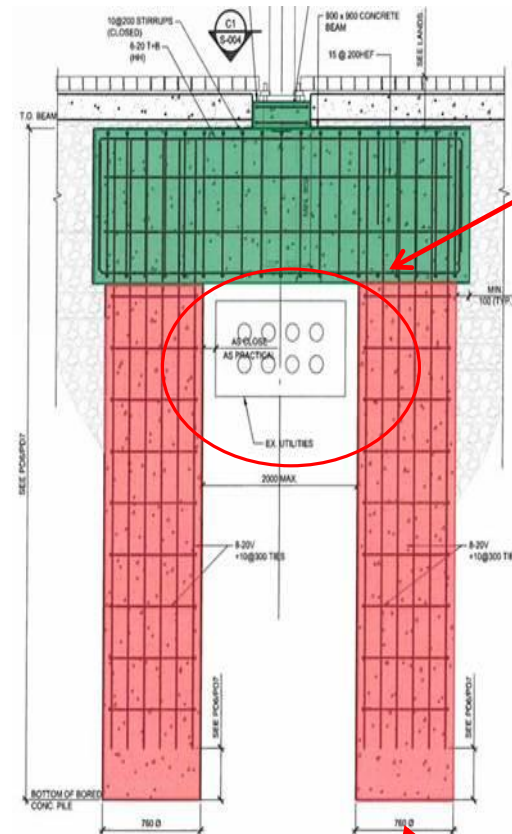
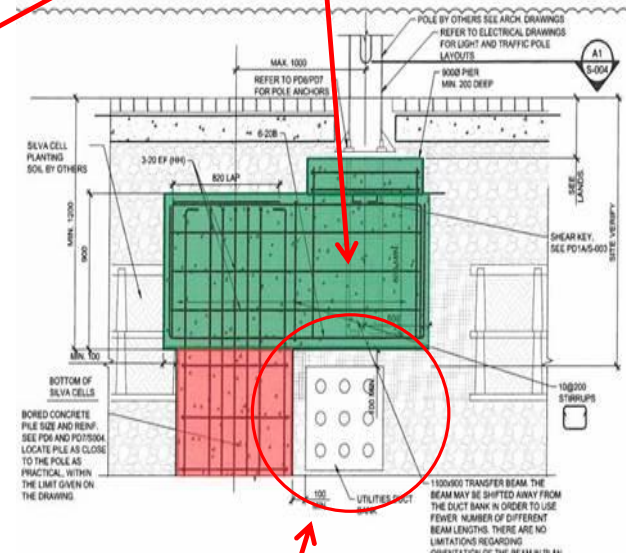
Ductbanks in conflict

Footings designed to manage conflicts

A typical street pole footing (above left) is drilled straight into the ground. To work around conflicting underground infrastructure new footings were designed that could bridge across the conflicts (above centre/right).

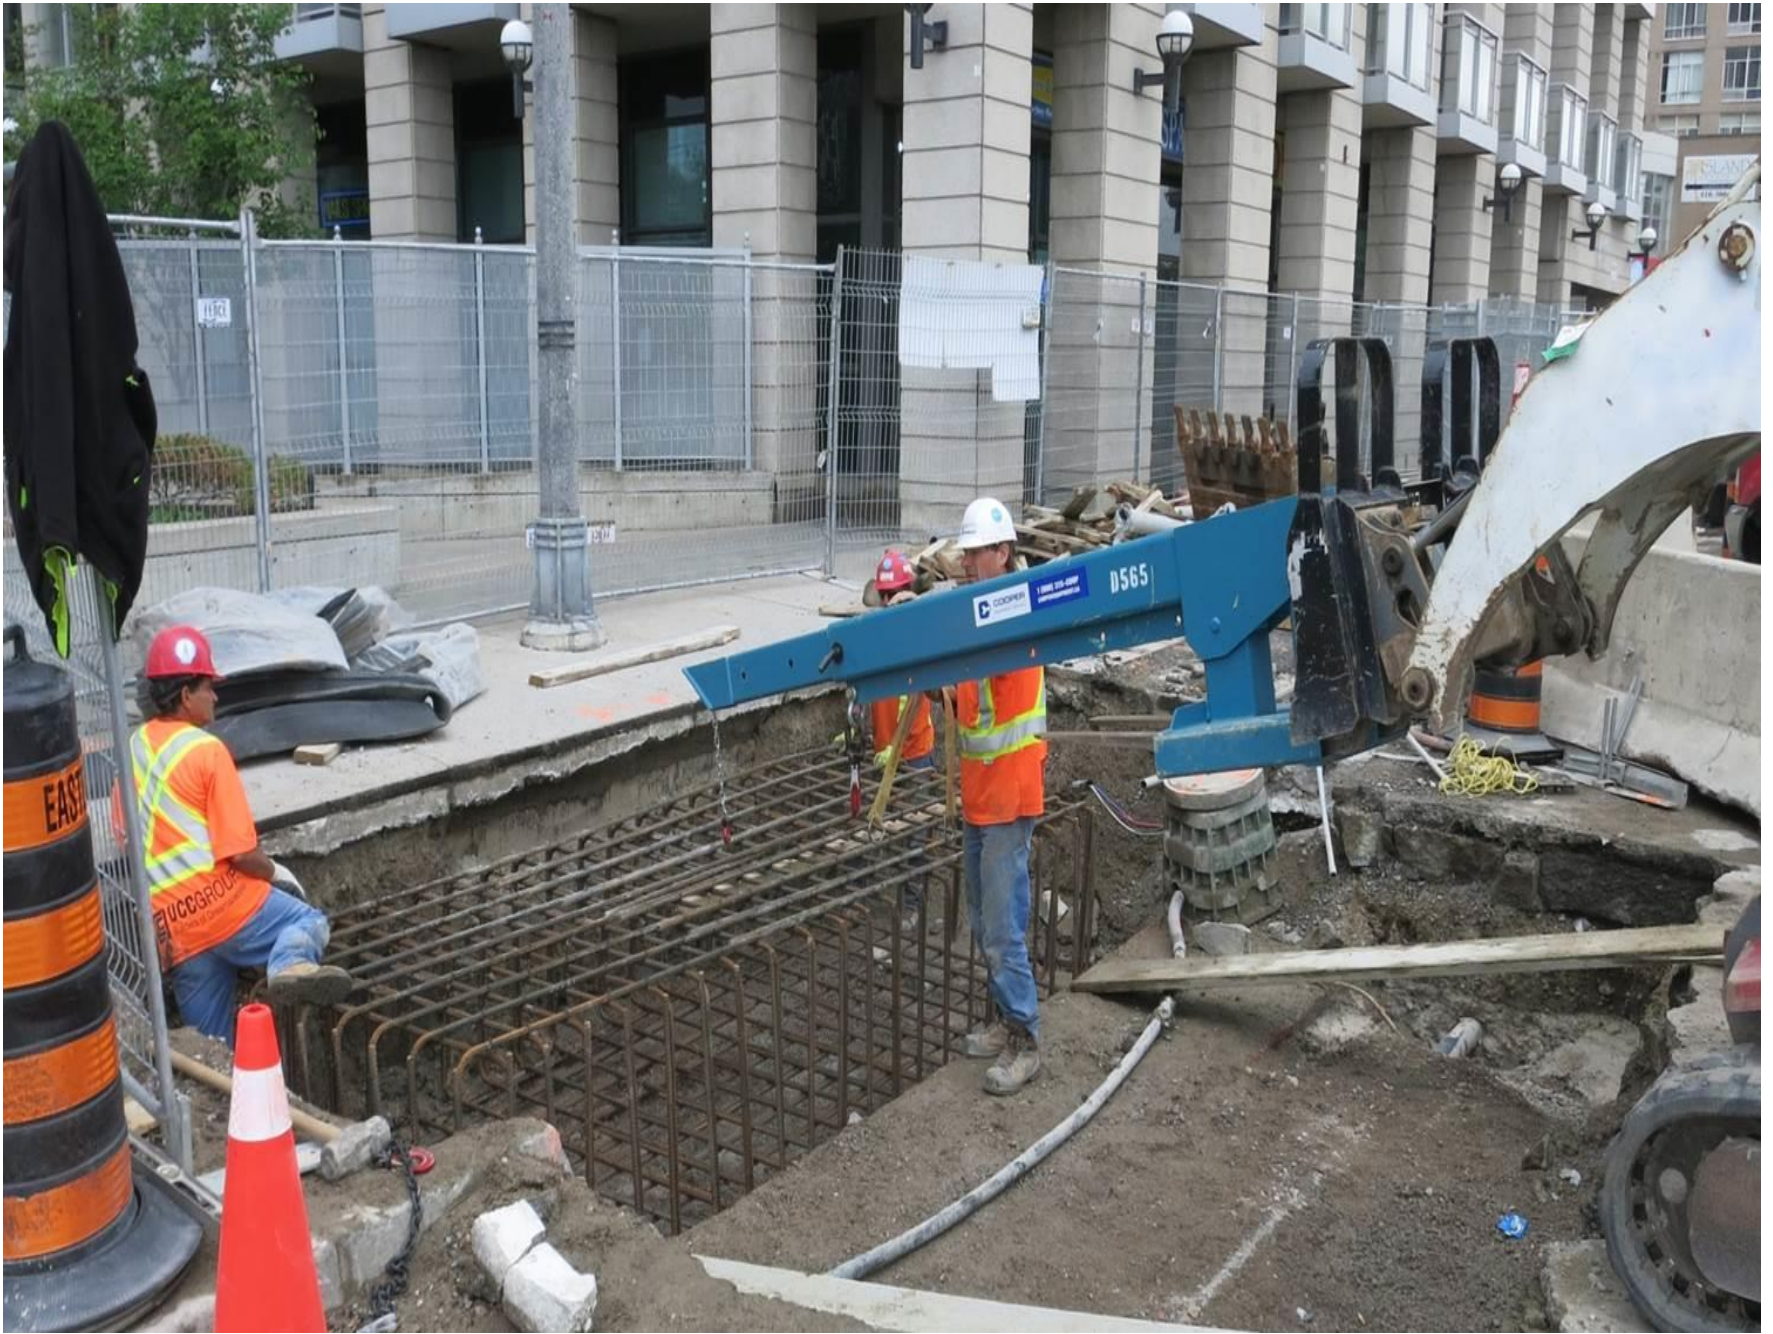
This is an example of the rebar required for one of the revised street pole footings needed to work around existing underground Hydro infrastructure that was not yet decommissioned as planned.

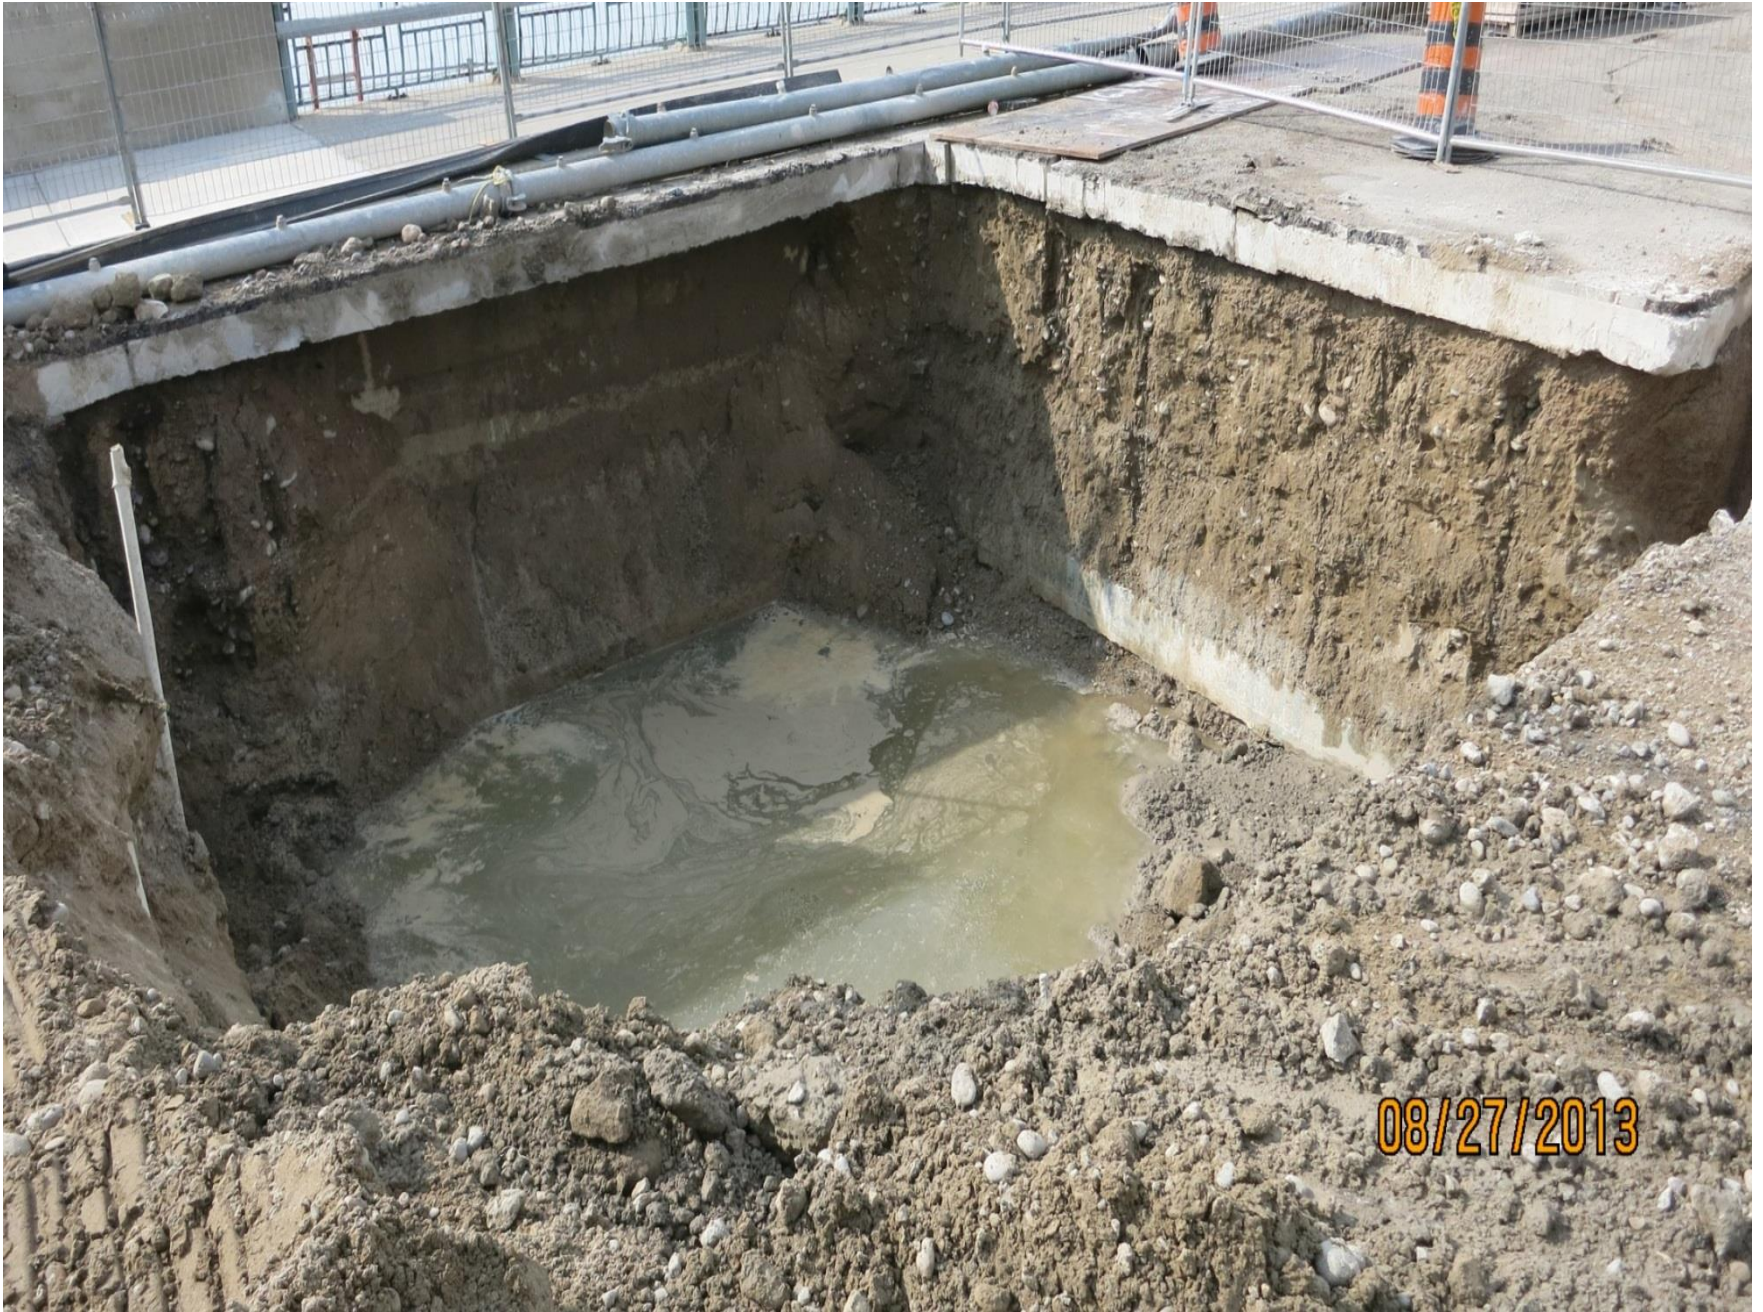
Waterfront construction requires extensive dewatering.

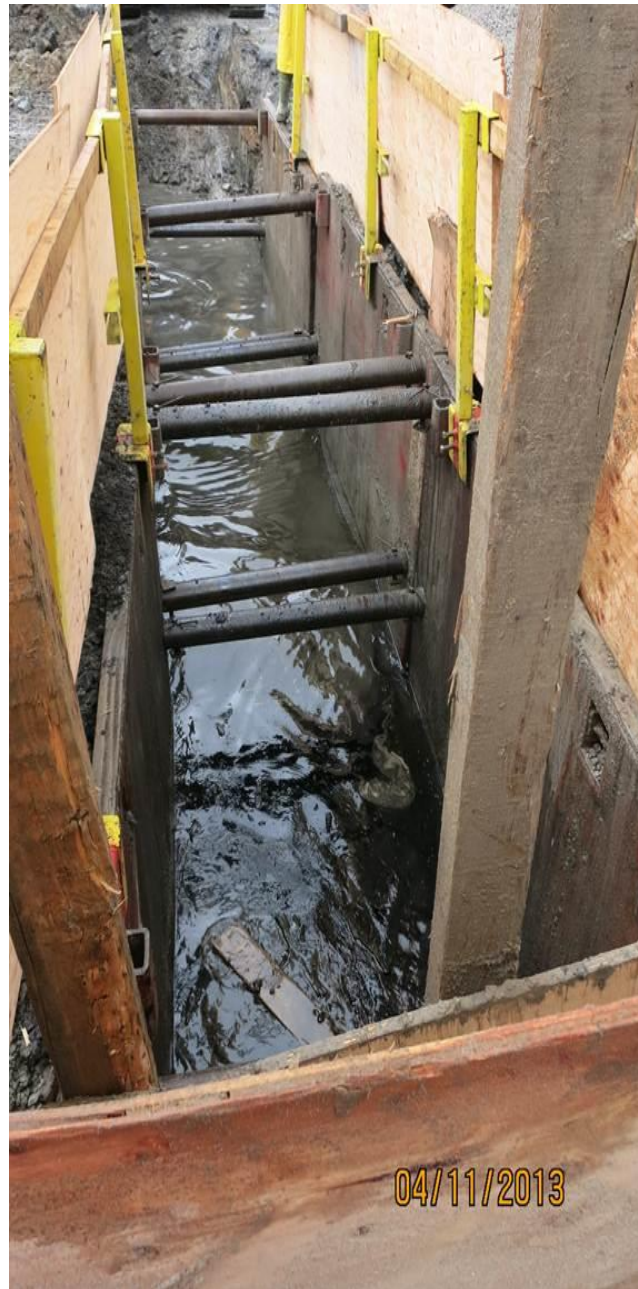
Due to difficulties with dewatering, water fills up the shoring used to keep the site safe and secure for underground infrastructure to be installed.

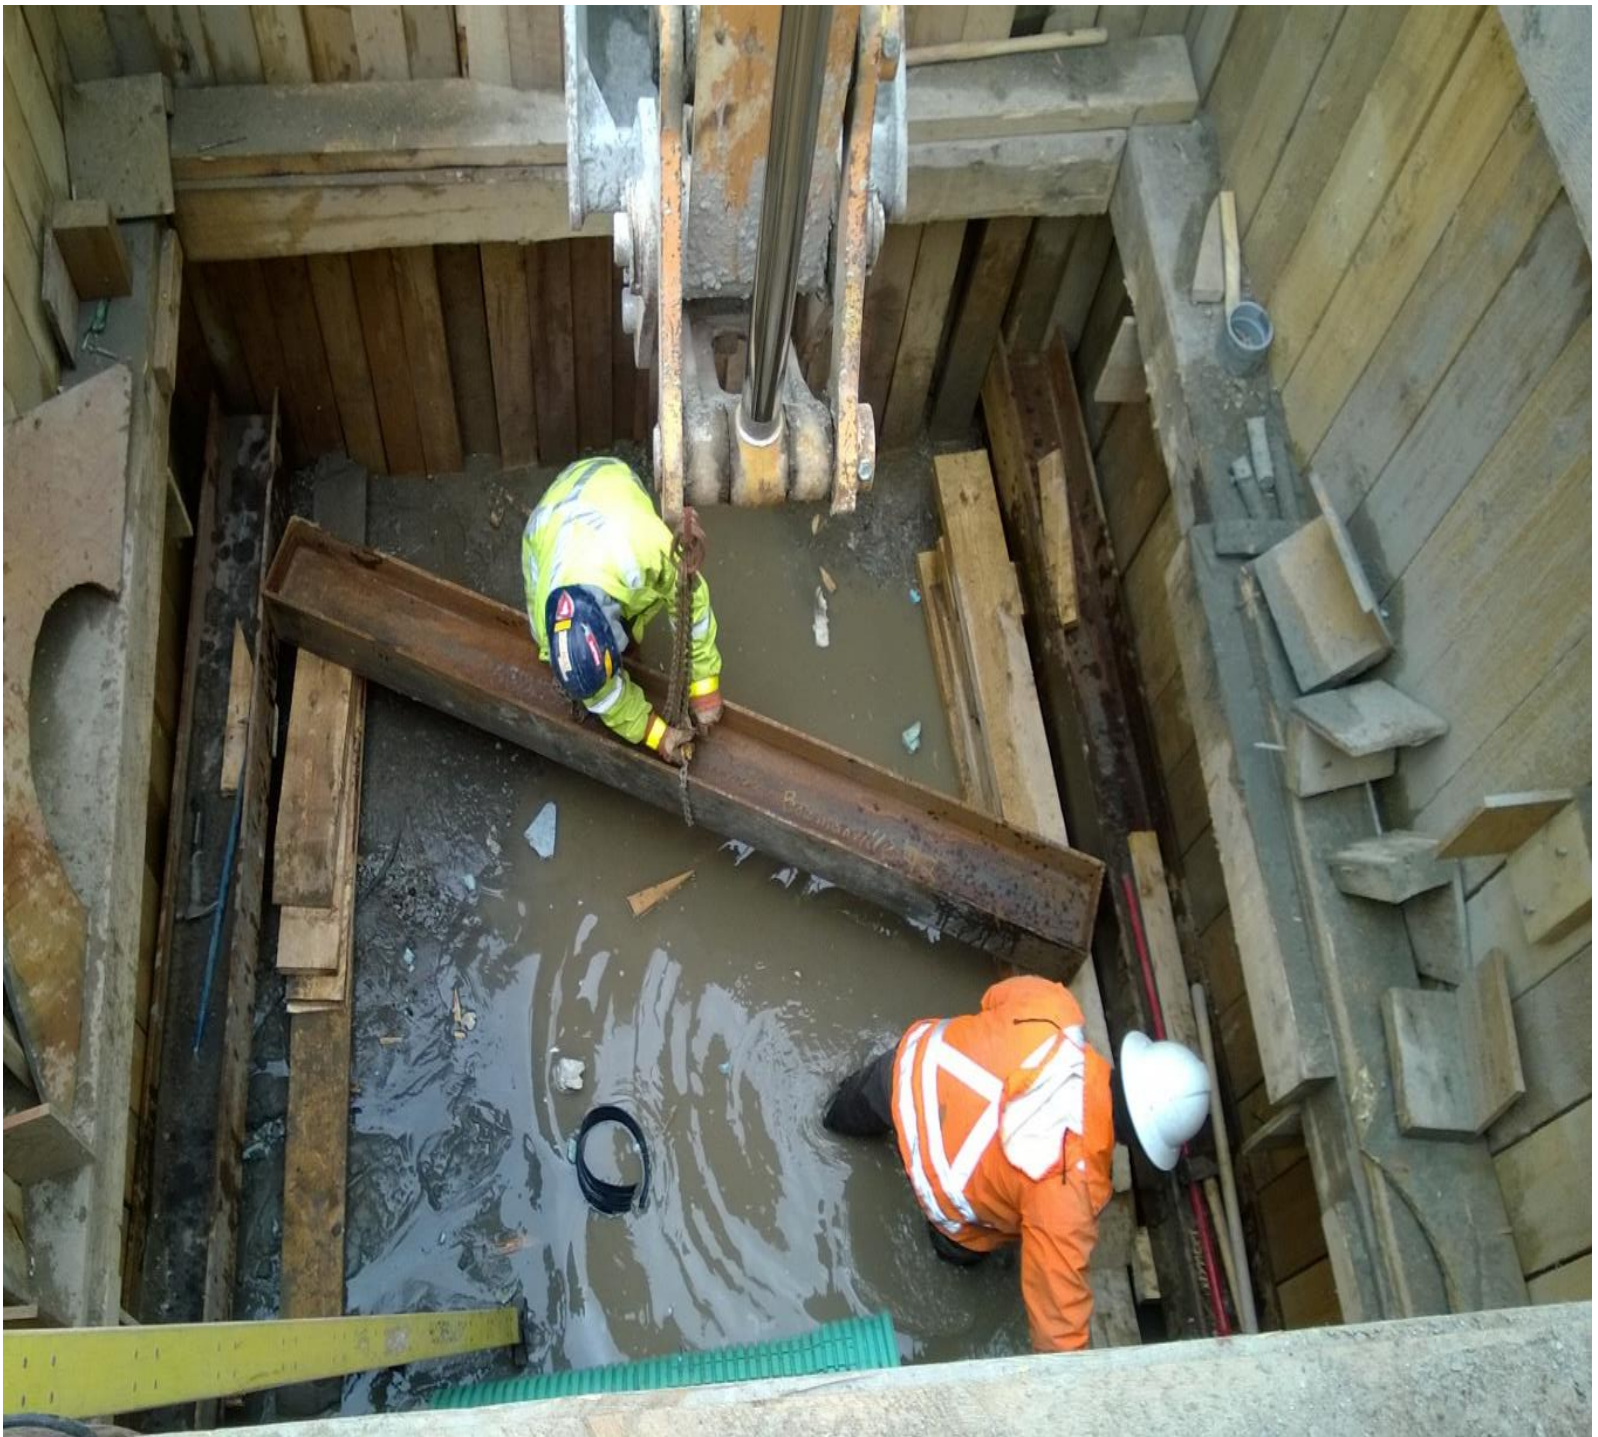
Another example of dewatering difficulties. Crews work in water in an underground chamber.

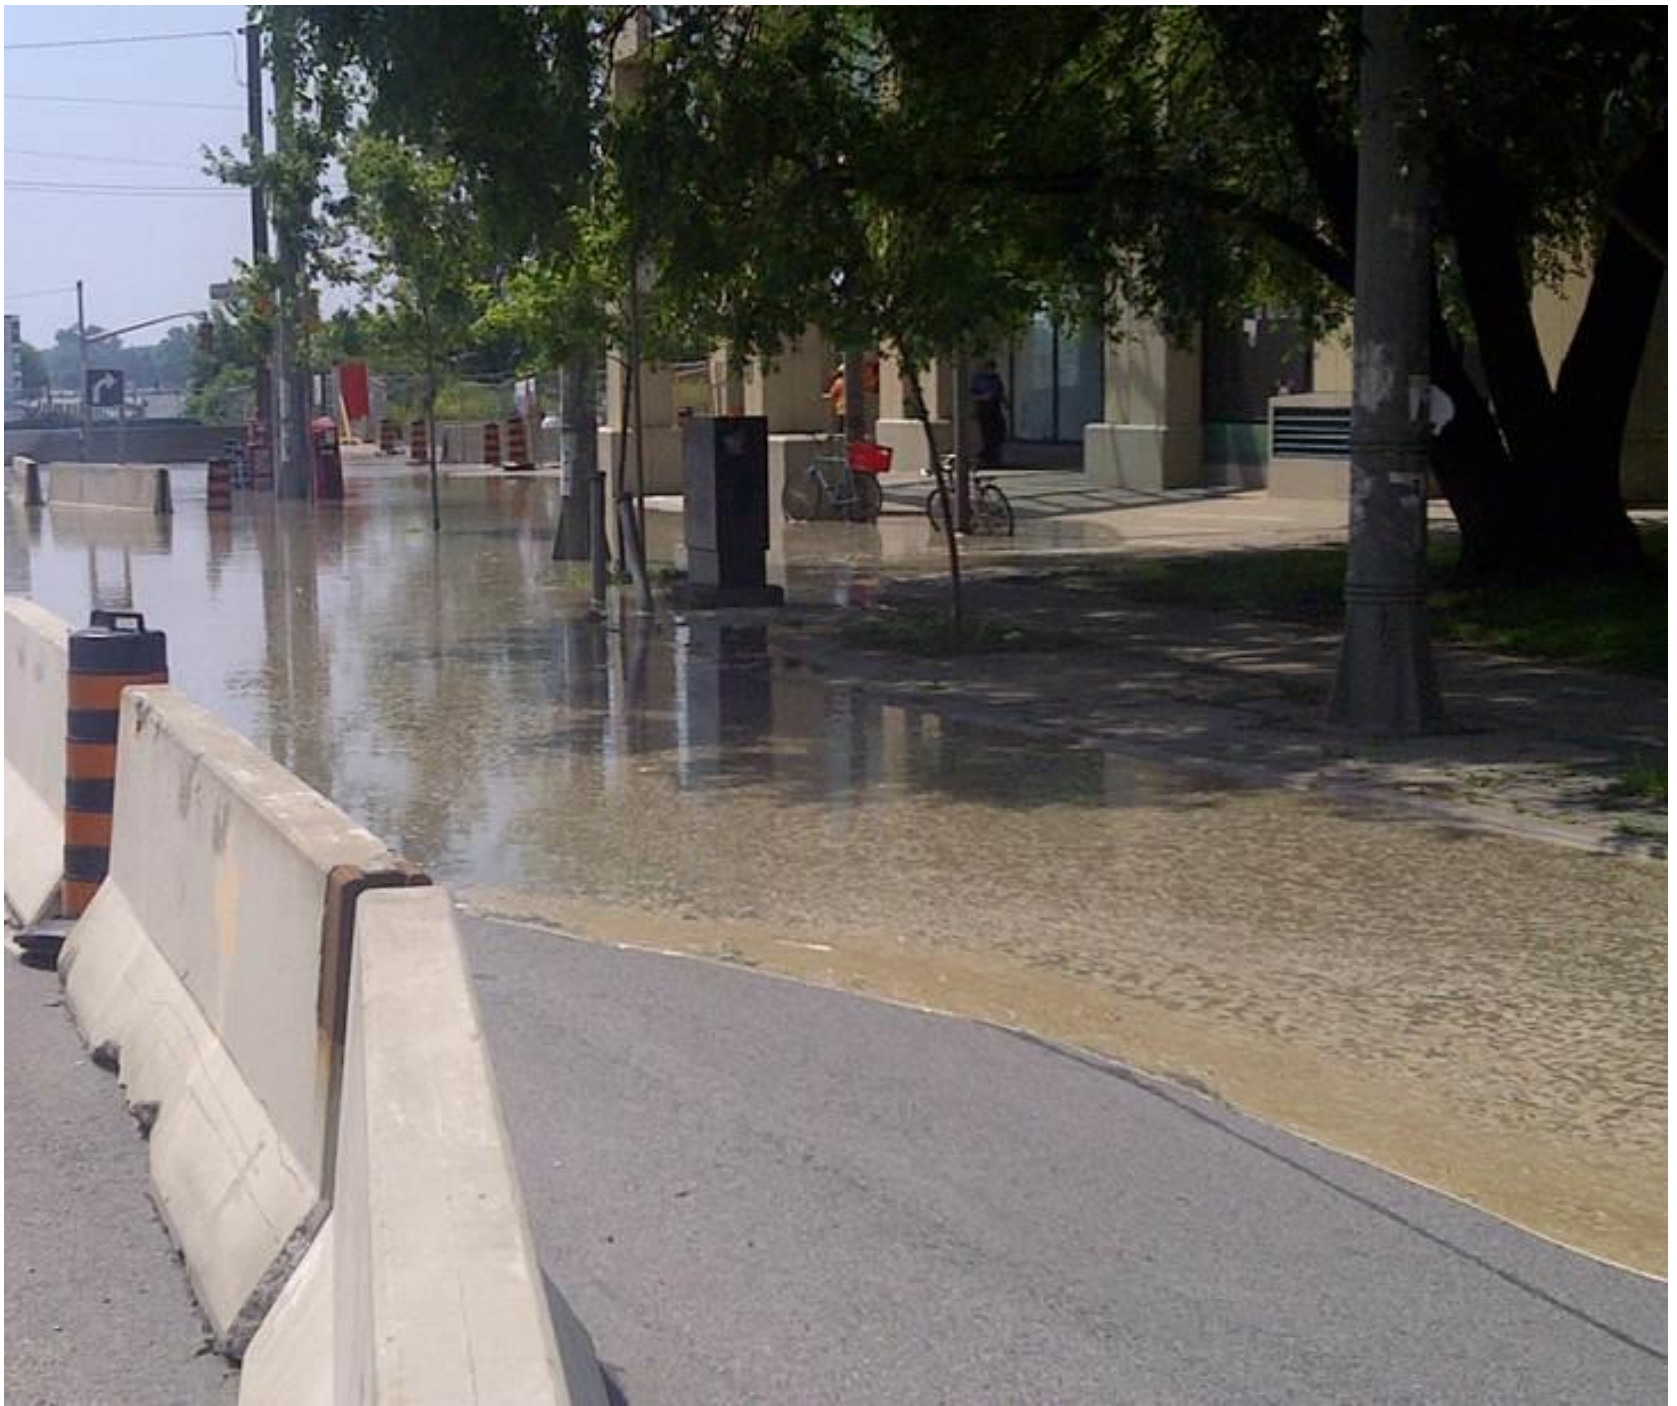
The significant flood which hit Toronto in July 2013 led the City of Toronto to cap the volume of water that could be discharged into the sanitary sewer. As a result, dewatering costs increased further.
