**Complex Site Conditions**

**110+ Conflicts**

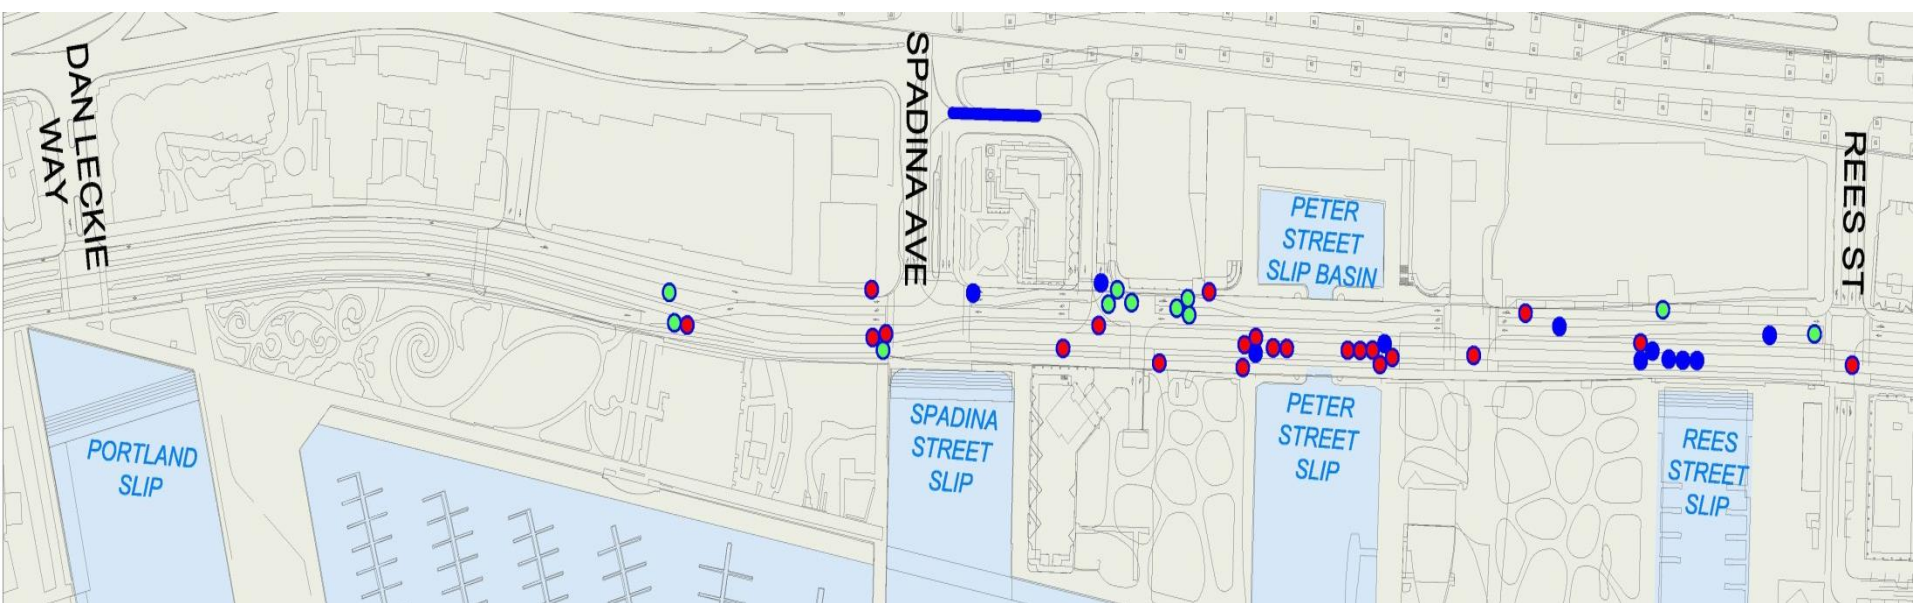
Dan Leckie to Rees

Aerial view showing several different contractors working across the site at the same time and the traffic management required to keep the street open to traffic

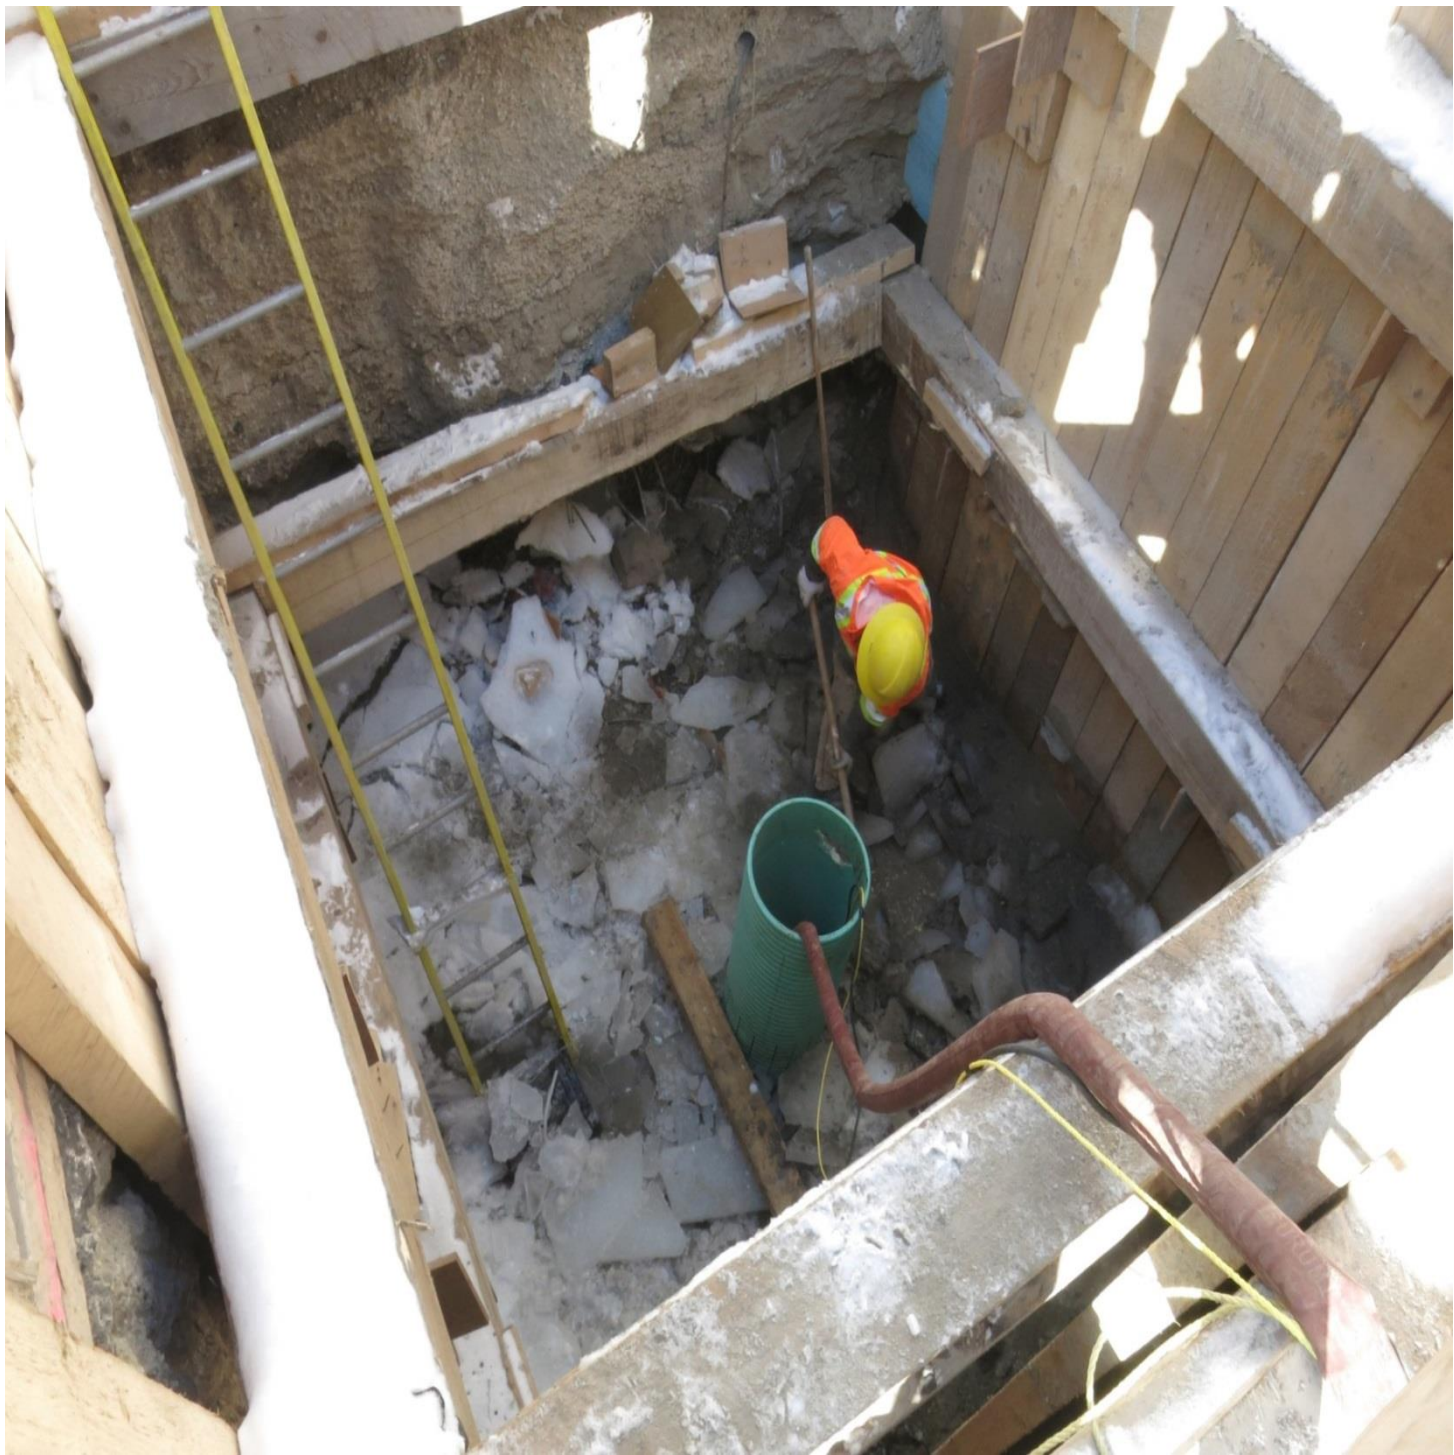
Due to required changes in construction staging, extensive winter work was required to work around conflicts and Toronto Hydro crews in order keep to the 2015 project schedule.

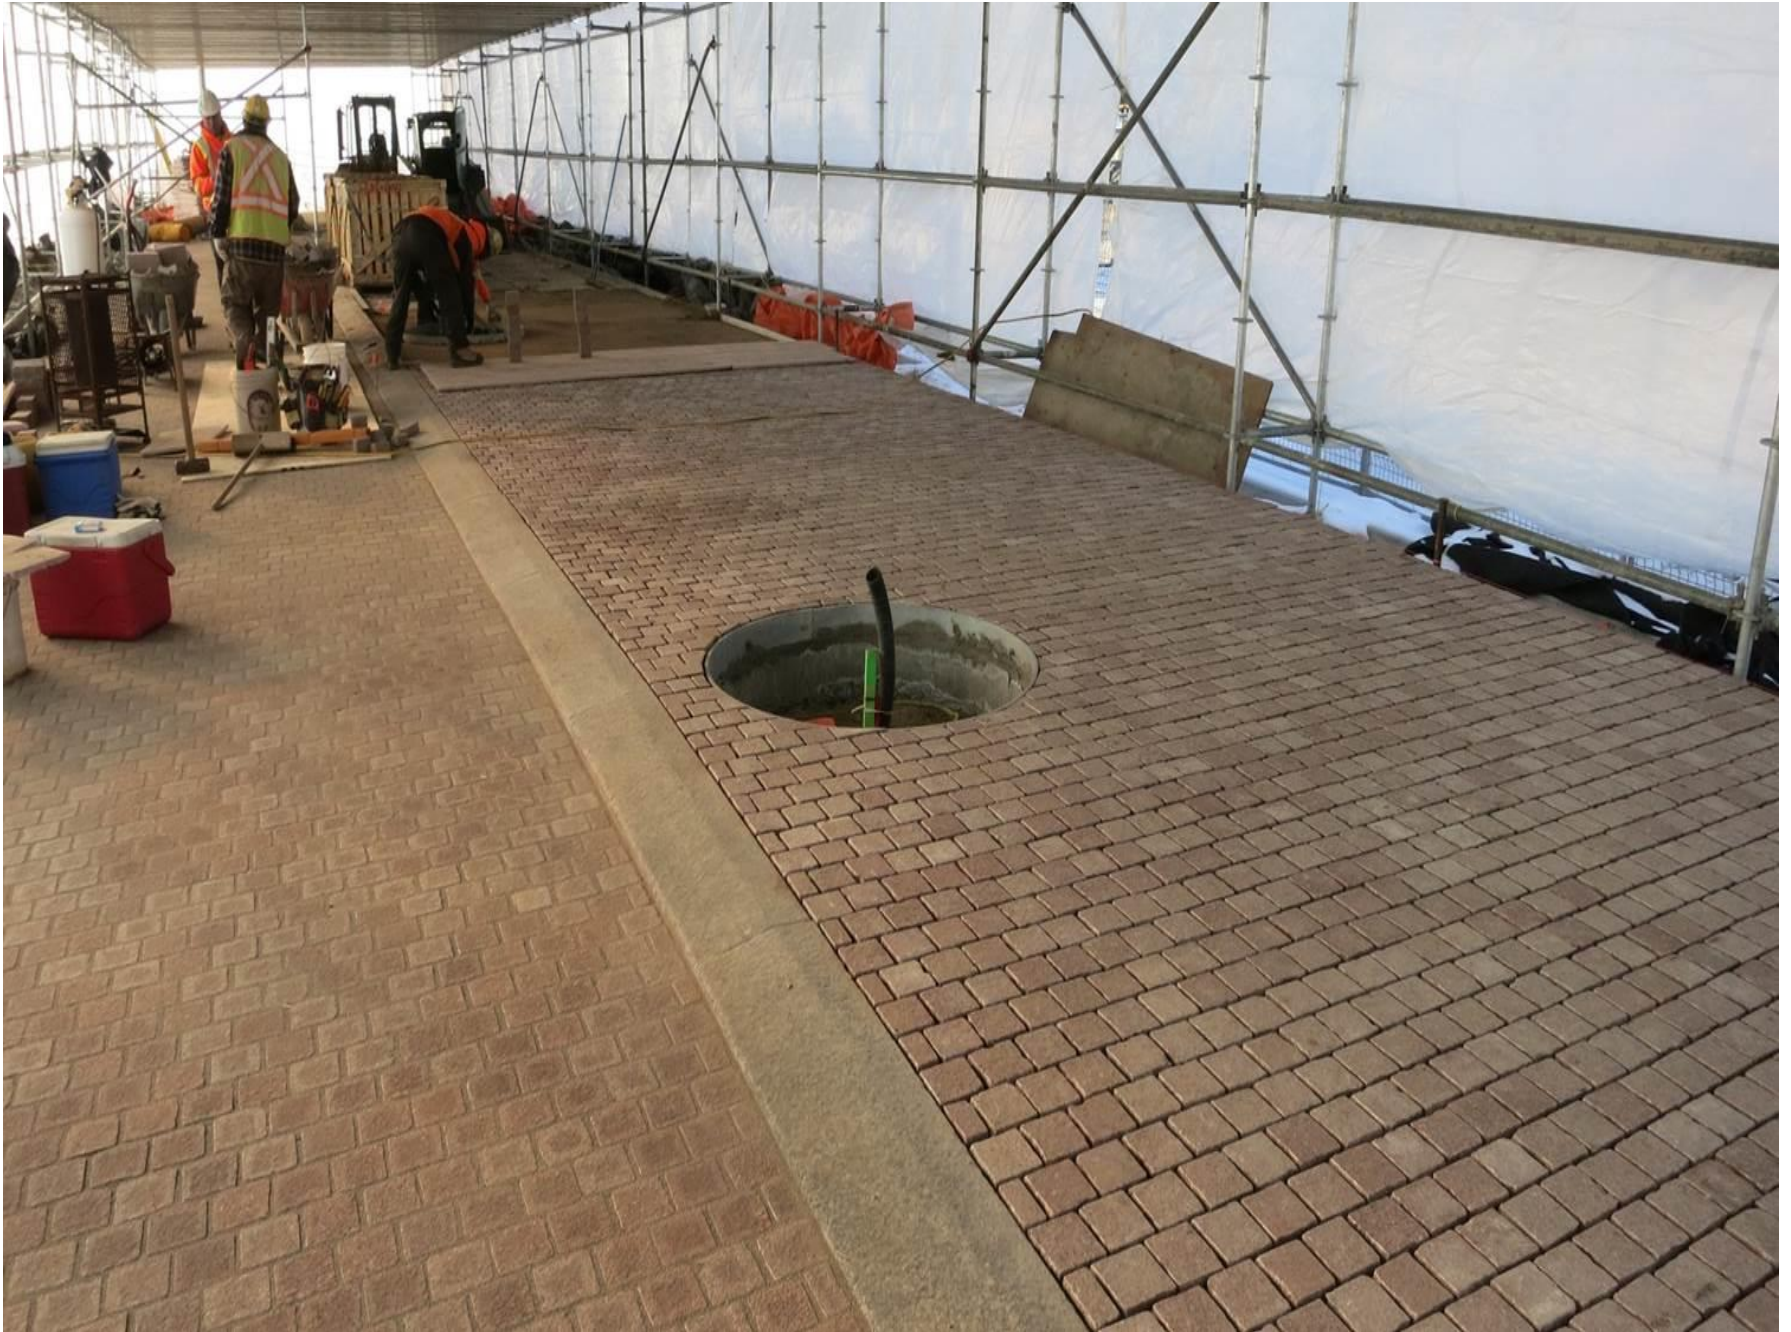
In order to keep to the 2015 schedule, granite work proceeded throughout the winter using tents and heaters which allow proper curing in frigid temperatures.

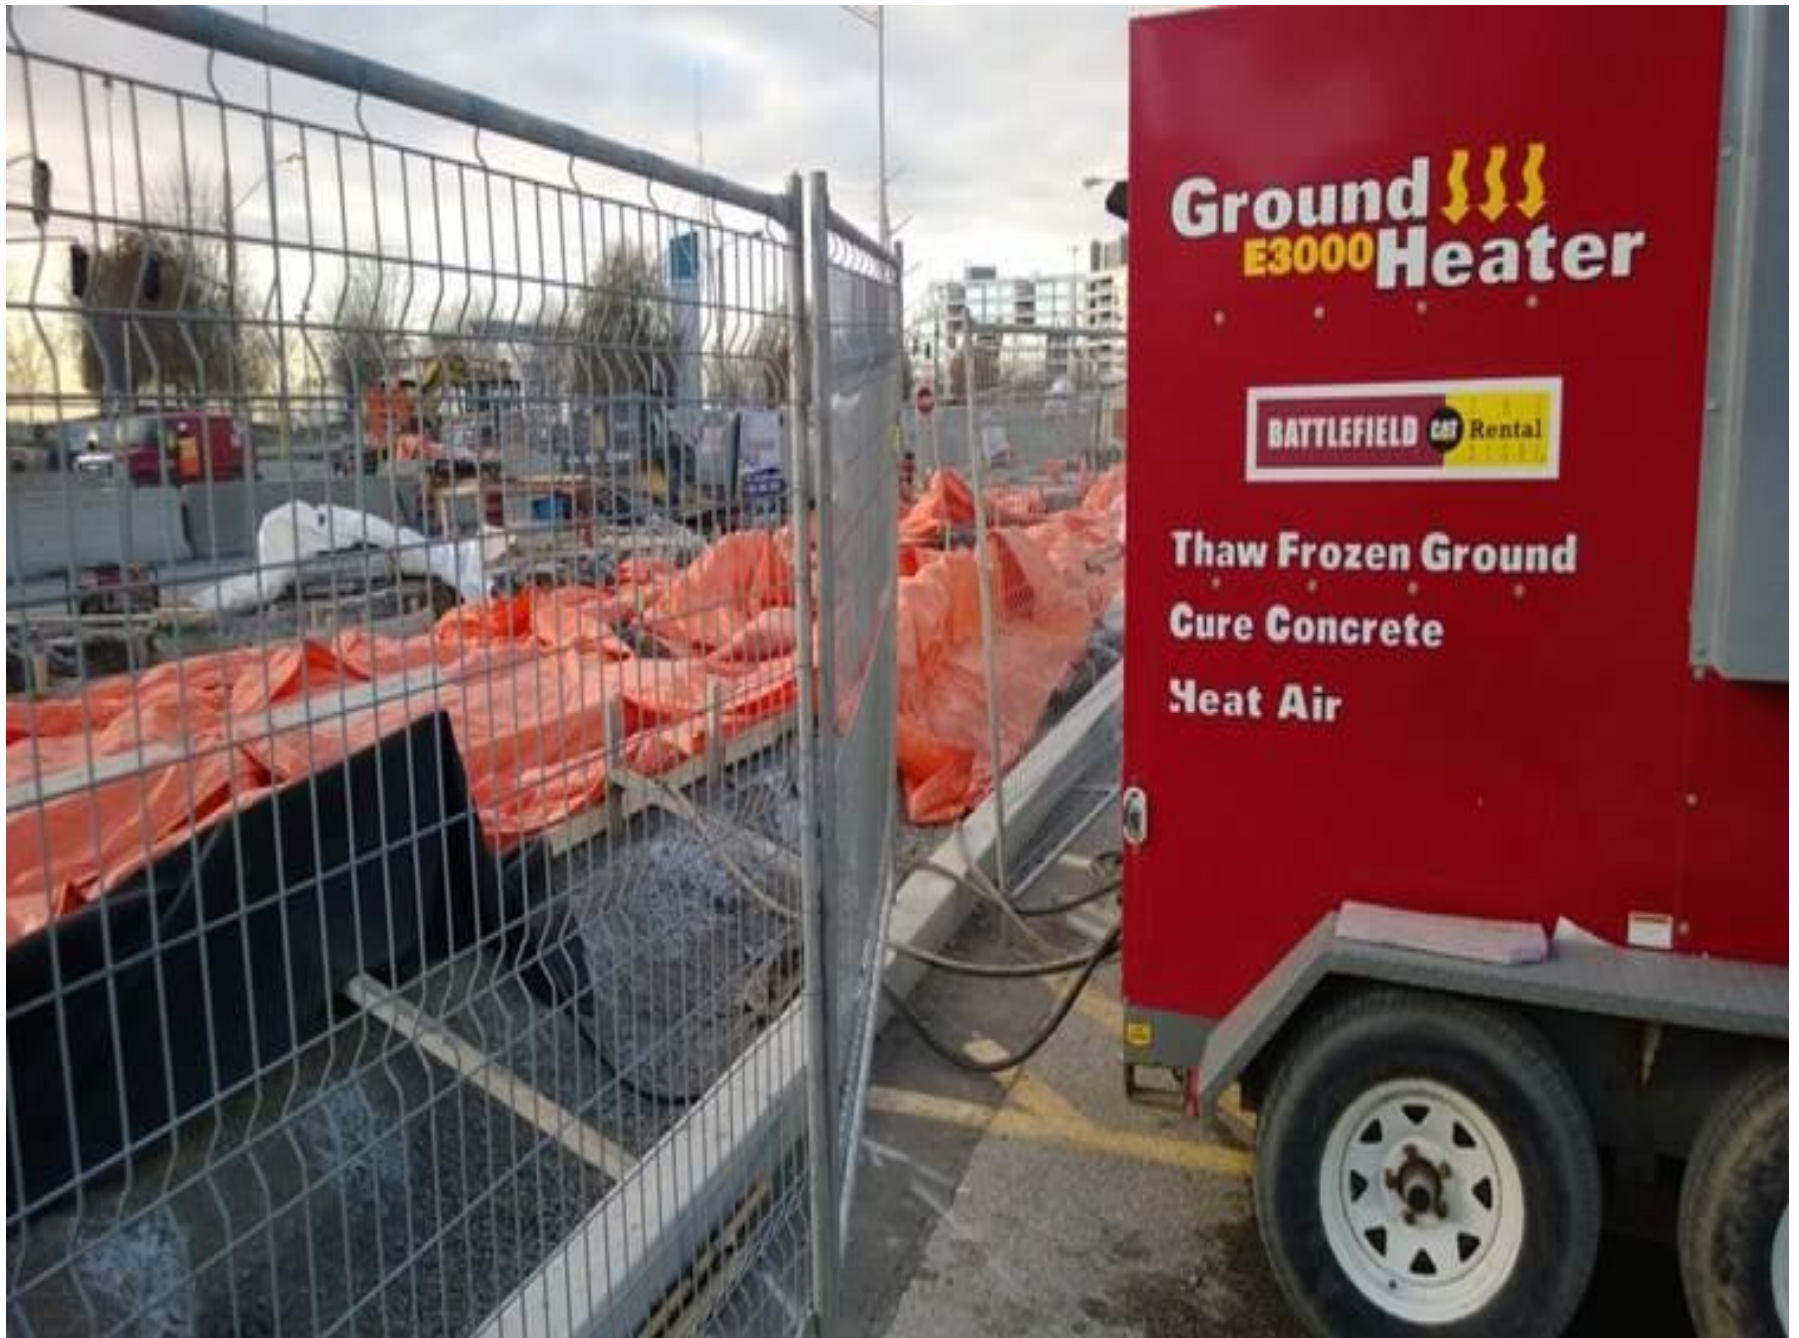
One example of ground heaters and tarps employed for winter work.
