GARDINER EXPRESSWAY AND LAKE SHORE BOULEVARD EAST RECONFIGURATION ENVIRONMENTAL ASSESSMENT

Appendix S – Road Safety Audit

SUBJECT: Gardiner-Lake Shore Boulevard East Reconfiguration EA – Safety Review Responses

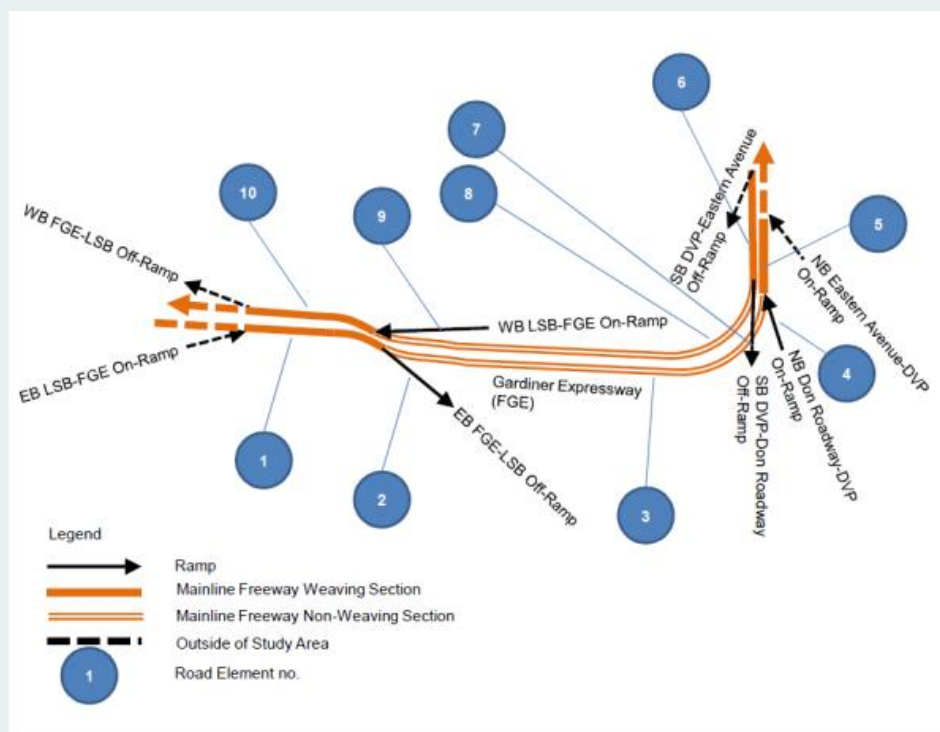
FIGURE 1: SAFETY ANALYSIS SECTIONS

This memo presents the status of the conceptual design of the three current Hybrid alternatives (Options 1, 2A and 3) with respect to addressing safety review comments chiefly outlined in AECOM's January 5, 2015 memorandum and Dillon's own in-house reviews. These reviews were based on initial, preliminary plans and profiles of the three alternatives. These alternatives are continuing to go through revision as the designs evolve and undergo more detailed evaluation and scrutiny. Figure 1, taken from the AECOM memo, was used to divide the project into sections to assist in the organization of this summary.

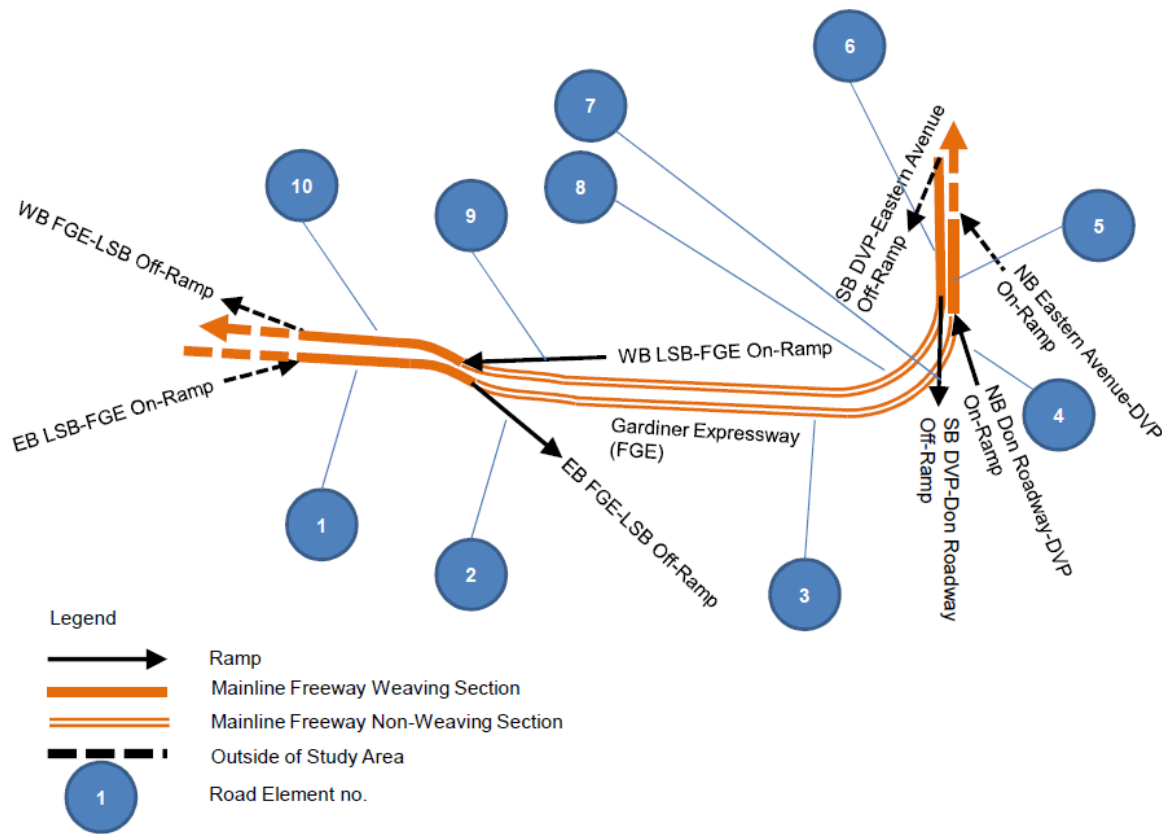
Figure 1 – Study Area Map

This memorandum is intended to provide a summary of findings from the review of the “preliminary” design drawings of the three “Hybrid” Alternative Design Concepts (namely, Alternative #1, Alternative #2A, and Alternative #3) of Gardiner Expressway (FGE)-Don Valley Parkway (DVP) ramps including on-ramps and off-ramps from / to Lakeshore (LSB) Boulevard to / from FGE and those from / to Don Roadway to / from DVP. This memorandum, where possible, also provides a list of potential treatments to mitigate the identified potential safety issues. The study area limits are Cherry Street to the west and Don Roadway to the east. Note that mid-block sections and intersections along LSB as well as non-elevated portions of FGE-DVP ramps are outside of study scope. The review process included a detailed review of the “preliminary” plan and profile drawings provided by Waterfront Toronto, and also considers the observations made during a site visit (on Thursday, November 19, 2015) of the study area, with a focus on the potential safety performance of various road elements within the study area. These road elements include mainline freeway weaving sections, mainline freeway non-weaving sections, and ramps located within the above-noted study area boundaries. Figure 1 shows a schematic map of the study area and its study road elements.
